Manhole Inspection Report

Date:	04/21/2018	Weather:		Coding:	RZMACP
MH#:	M-806-028	Owner:	NA	Len. Surveyed:	8.9
P.O.#:		Surveyor:	John Kuglmaier	Rim to Invert:	9.2
Customer:		Cert. #:	U-1215-07002349	Wall Material:	Concrete (reinforced)

Street:	Springdale Dr. 387' North of 9th Ct.	Project:	Hobart, IN
City:	Hobart, IN	GPS Northing:	0.0
Location:		GPS Easting:	0.0
Drain Area:	Southeast	GPS Accuracy:	Nearest Meter
Cover Shape:	Circular	Evidence of Surcharge:	No
Cover Size:	22.5	Potential for Runoff:	None
Comments:

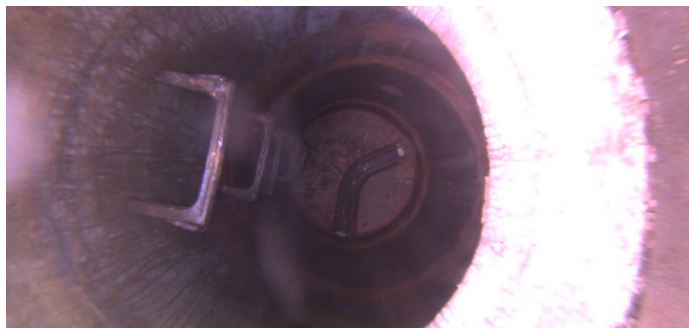
Code: **MGP**
Description: **General Photo**

Distance (ft): **.0**
Structural Grade: **0**
O&M Grade: **0**
Clock Start/From:
Clock To:
1st Value:
2nd Value:
Value Percent:
Step: **NO**
Remarks:

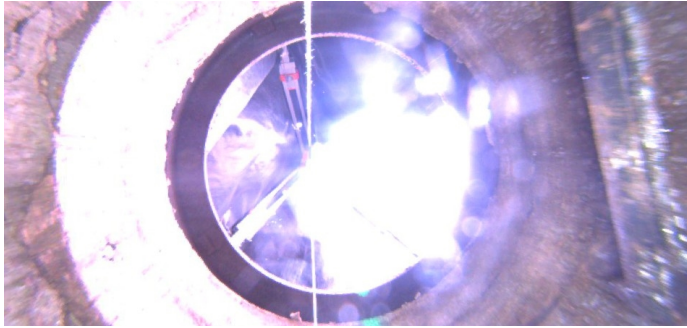
Code: **MGP**
Description: **General Photo**

Distance (ft): **2.6**
Structural Grade: **0**
O&M Grade: **0**
Clock Start/From:
Clock To:
1st Value:
2nd Value:
Value Percent:
Step: **NO**
Remarks:

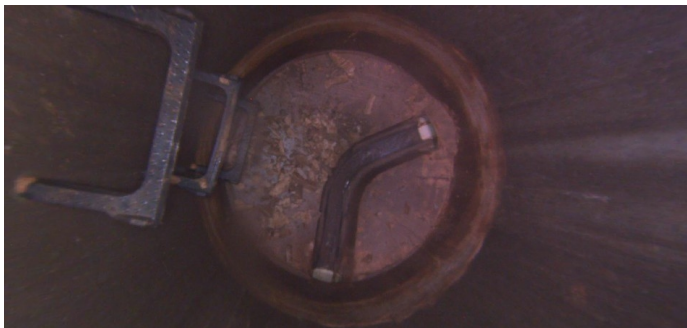
Code: **IS**
Description: **Infil Stain**

Distance (ft): **4.3**
Structural Grade: **0**
O&M Grade: **0**
Clock Start/From: **12**
Clock To: **12**
1st Value:
2nd Value:
Value Percent:
Step: **NO**
Remarks:

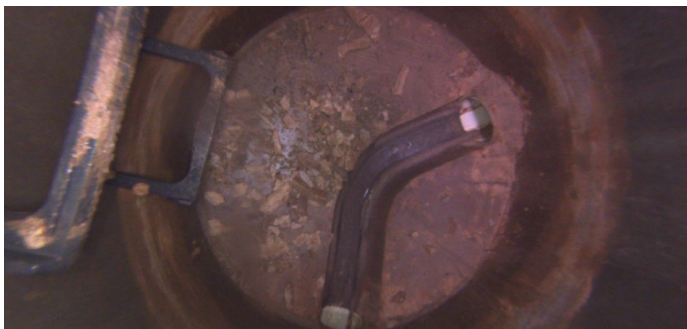
Code: **DAZ**
Description: **Deposits Attached Other**

Distance (ft): **5.9**
Structural Grade: **0**
O&M Grade: **2**
Clock Start/From: **12**
Clock To: **12**
1st Value:
2nd Value:
Value Percent: **5.000**
Step: **NO**
Remarks: **Mixed materials**

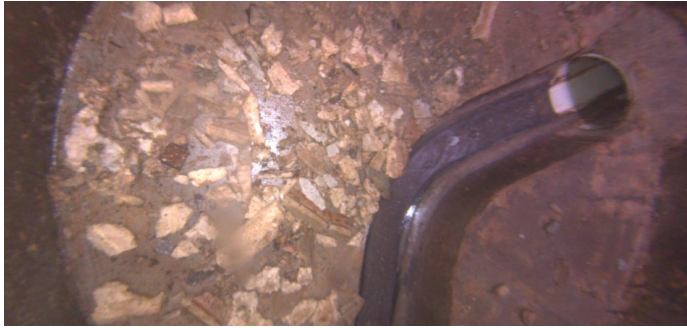
Code:	MGO
Description:	General Observation
Distance (ft):	7.6
Structural Grade:	0
O&M Grade:	0
Clock Start/From:	
Clock To:	
1st Value:	
2nd Value:	
Value Percent:	
Step:	NO
Remarks:	Ins. Comp.
