Manhole Inspection Report

Date:	04/21/2018	Weather:		Coding:	RZMACP
MH#:	M-806-030	Owner:	NA	Len. Surveyed:	7.8
P.O.#:		Surveyor:	John Kuglmaier	Rim to Invert:	7.9
Customer:		Cert. #:	U-1215-07002349	Wall Material:	Concrete (reinforced)

Street:	9th Ct. off of Springdale Dr.	Project:	Hobart, IN
City:	Hobart, IN	GPS Northing:	0.0
Location:		GPS Easting:	0.0
Drain Area:	Southeast	GPS Accuracy:	Nearest Meter
Cover Shape:	Circular	Evidence of Surcharge:	No
Cover Size:	22.5	Potential for Runoff:	None
Comments:

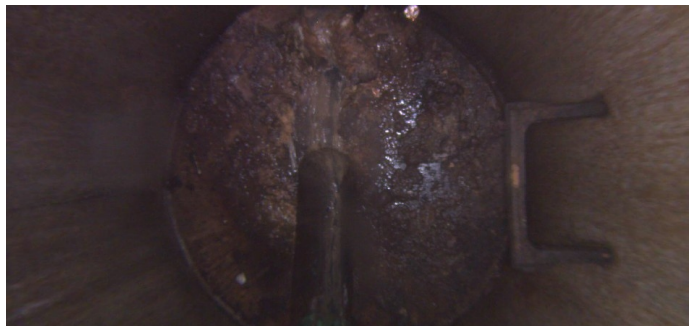
Code: **DAZ**
Description: **Deposits Attached Other**

Distance (ft): **4.9**
Structural Grade: **0**
O&M Grade: **2**
Clock Start/From: **12**
Clock To: **12**
1st Value:
2nd Value:
Value Percent: **5.000**
Step: **NO**
Remarks: **Mixed materials**
