Manhole Inspection Report

Date:	04/21/2018	Weather:		Coding:	RZMACP
MH#:	M-806-031	Owner:	NA	Len. Surveyed:	7.6
P.O.#:		Surveyor:	John Kuglmaier	Rim to Invert:	7.7
Customer:		Cert. #:	U-1215-07002349	Wall Material:	Concrete (reinforced)

Street:	Springdale Dr. 291' South of 9th Ct.	Project:	Hobart, IN
City:	Hobart, IN	GPS Northing:	0.0
Location:		GPS Easting:	0.0
Drain Area:	Southeast	GPS Accuracy:	Nearest Meter
Cover Shape:	Circular	Evidence of Surcharge:	No
Cover Size:	22.5	Potential for Runoff:	None
Comments:

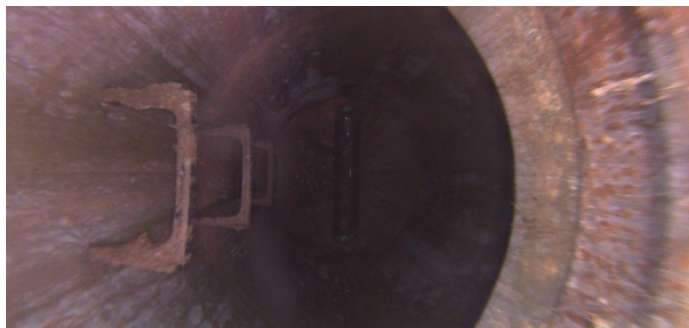
Code: **MGP**
Description: **General Photo**

Distance (ft): **.0**
Structural Grade: **0**
O&M Grade: **0**
Clock Start/From:
Clock To:
1st Value:
2nd Value:
Value Percent:
Step: **NO**
Remarks:

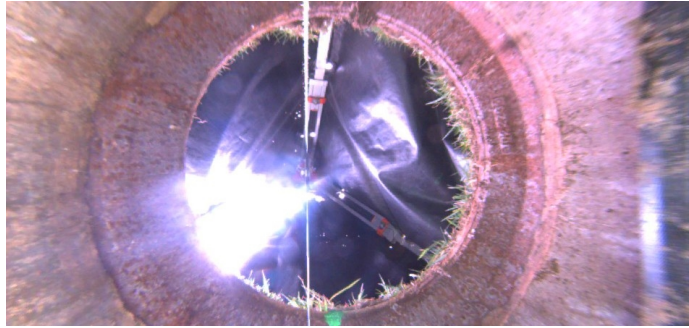
Code: **MGP**
Description: **General Photo**

Distance (ft): **2.4**
Structural Grade: **0**
O&M Grade: **0**
Clock Start/From:
Clock To:
1st Value:
2nd Value:
Value Percent:
Step: **NO**
Remarks:

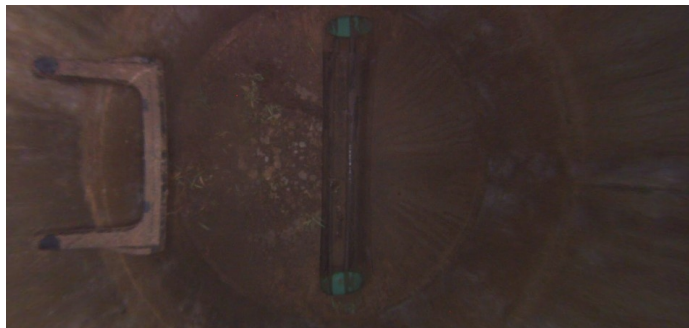
Code: **DSF**
Description: **Deposits Settled Fine**

Distance (ft): **4.3**
Structural Grade: **0**
O&M Grade: **2**
Clock Start/From: **12**
Clock To: **12**
1st Value:
2nd Value:
Value Percent: **5.000**
Step: **NO**
Remarks:

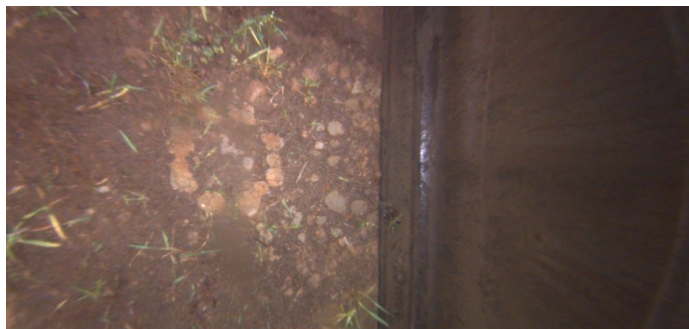
Code: **MGO**
Description: **General Observation**

Distance (ft): **6.4**
Structural Grade: **0**
O&M Grade: **0**
Clock Start/From:
Clock To:
1st Value:
2nd Value:
Value Percent:
Step: **NO**
Remarks: **Ins. Comp.**
