Manhole Inspection Report

Date:	04/21/2018	Weather:		Coding:	RZMACP
MH#:	M-806-032	Owner:	NA	Len. Surveyed:	7.8
P.O.#:		Surveyor:	John Kuglmaier	Rim to Invert:	7.7
Customer:		Cert. #:	U-1215-07002349	Wall Material:	Concrete (reinforced)

Street:	Springdale Dr. 119' North of 10th St.	Project:	Hobart, IN
City:	Hobart, IN	GPS Northing:	0.0
Location:		GPS Easting:	0.0
Drain Area:	Southeast	GPS Accuracy:	Nearest Meter
Cover Shape:	Circular	Evidence of Surcharge:	No
Cover Size:	22.5	Potential for Runoff:	None
Comments:

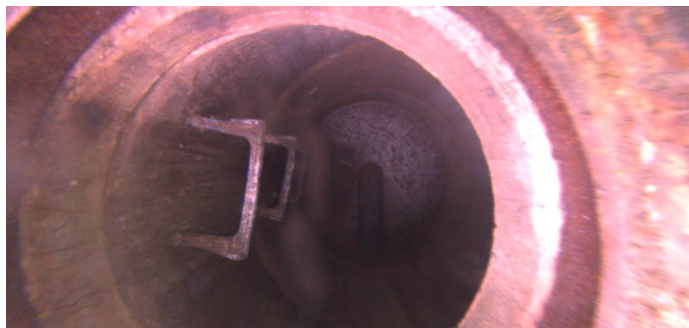
Code: **MGP**
Description: **General Photo**

Distance (ft): **.0**
Structural Grade: **0**
O&M Grade: **0**
Clock Start/From:
Clock To:
1st Value:
2nd Value:
Value Percent:
Step: **NO**
Remarks:

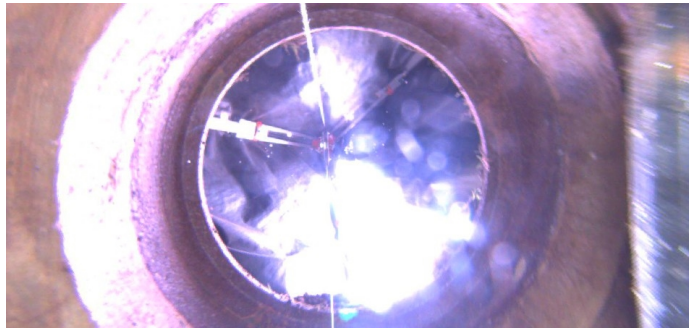
Code: **MGP**
Description: **General Photo**

Distance (ft): **2.7**
Structural Grade: **0**
O&M Grade: **0**
Clock Start/From:
Clock To:
1st Value:
2nd Value:
Value Percent:
Step: **NO**
Remarks:

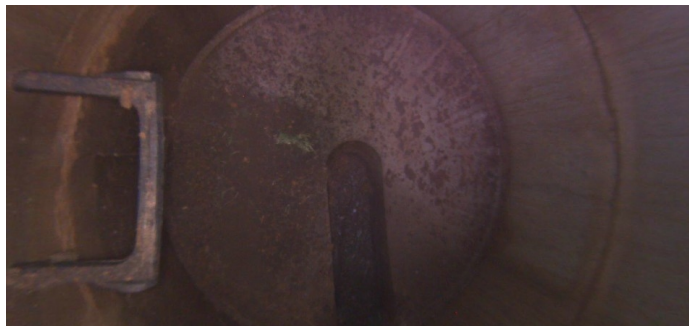
Code: **DSF**
Description: **Deposits Settled Fine**

Distance (ft): **4.6**
Structural Grade: **0**
O&M Grade: **2**
Clock Start/From: **12**
Clock To: **12**
1st Value:
2nd Value:
Value Percent: **5.000**
Step: **NO**
Remarks:

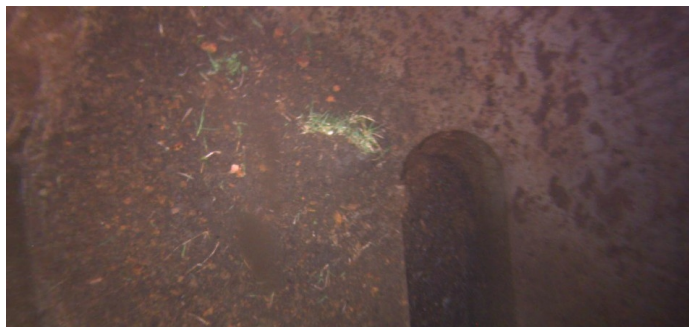
Code: **MGO**
Description: **General Observation**

Distance (ft): **6.6**
Structural Grade: **0**
O&M Grade: **0**
Clock Start/From:
Clock To:
1st Value:
2nd Value:
Value Percent:
Step: **NO**
Remarks: **Ins. Comp.**
