Manhole Inspection Report

Date:	04/21/2018	Weather:		Coding:	RZMACP
MH#:	M-806-033	Owner:	NA	Len. Surveyed:	6.4
P.O.#:		Surveyor:	Jen Costello	Rim to Invert:	6.9
Customer:		Cert. #:	U-907-5518	Wall Material:	Concrete (reinforced)

Street:	Starboard Ct. to the East.	Project:	Hobart, IN
City:	Hobart, IN	GPS Northing:	0.0
Location:		GPS Easting:	0.0
Drain Area:	Southeast	GPS Accuracy:	Nearest Meter
Cover Shape:	Circular	Evidence of Surcharge:	No
Cover Size:	22.5	Potential for Runoff:	None
Comments:

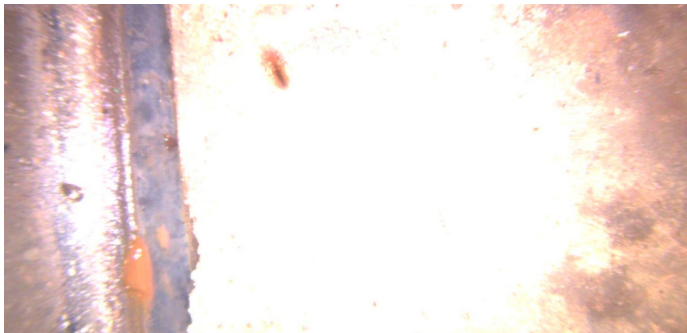
Code:	MGO
Description:	General Observation
Distance (ft):	1.7
Structural Grade:	0
O&M Grade:	0
Clock Start/From:	
Clock To:	
1st Value:	
2nd Value:	
Value Percent:	
Step:	NO
Remarks:	UNDERSIDE OF FRAME
