Manhole Inspection Report

Date:	04/24/2018	Weather:		Coding:	RZMACP
MH#:	M-806-034	Owner:	NA	Len. Surveyed:	7.4
P.O.#:		Surveyor:	John Kuglmaier	Rim to Invert:	7.2
Customer:	8.7	Cert. #:	U-1215-07002349	Wall Material:	Concrete (reinforced)

Street:	Starboard Ct. to the West.	Project:	Hobart, IN
City:	Hobart, IN	GPS Northing:	0.0
Location:		GPS Easting:	0.0
Drain Area:	Southeast	GPS Accuracy:	Nearest Meter
Cover Shape:	Circular	Evidence of Surcharge:	No
Cover Size:	22.5	Potential for Runoff:	None
Comments:

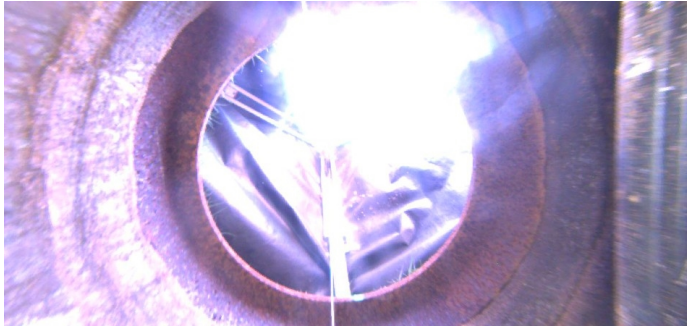
Code: **MGP**
Description: **General Photo**

Distance (ft): **2.4**
Structural Grade: **0**
O&M Grade: **0**
Clock Start/From:
Clock To:
1st Value:
2nd Value:
Value Percent:
Step: **NO**
Remarks:

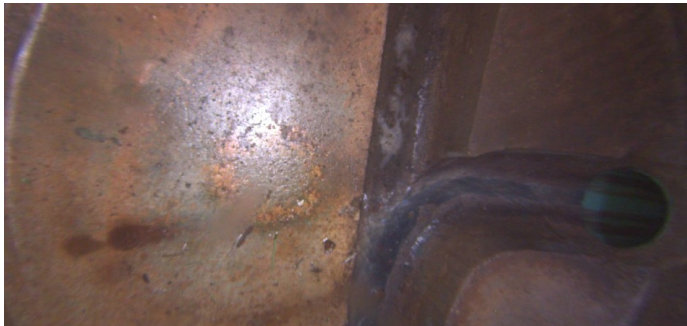
Code: **MGO**
Description: **General Observation**

Distance (ft): **6.3**
Structural Grade: **0**
O&M Grade: **0**
Clock Start/From:
Clock To:
1st Value:
2nd Value:
Value Percent:
Step: **NO**
Remarks: **Ins. Comp.**
