# Manhole Inspection Report

| MH#: | <b>M-806-037</b> | Owner: | <b>NA</b> | Len. Surveyed: | <b>6.9</b> |

| Street: | <b>Port Ct. North end.</b> | Project: | <b>Hobart, IN</b> |

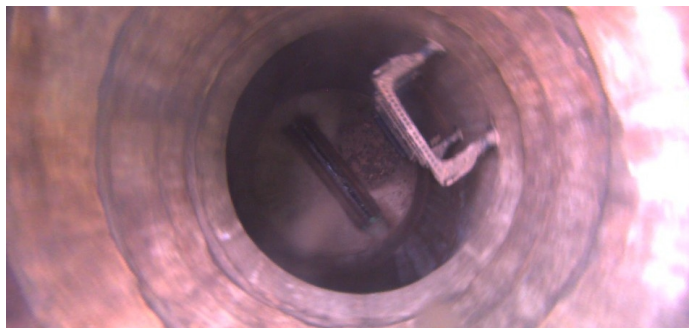
Code: **MGP**  
Description: **General Photo**

Distance (ft): **.0**  
Structural Grade: **0**  
O&M Grade: **0**  
Clock Start/From:  
Clock To:  
1st Value:  
2nd Value:  
Value Percent:  
Step: **NO**  
Remarks:

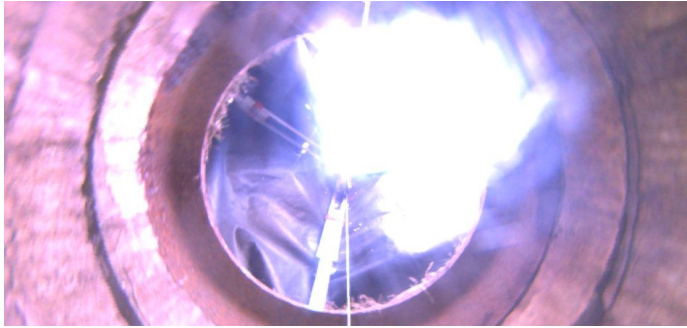
Code: **MGP**  
Description: **General Photo**

Distance (ft): **2.5**  
Structural Grade: **0**  
O&M Grade: **0**  
Clock Start/From:  
Clock To:  
1st Value:  
2nd Value:  
Value Percent:  
Step: **NO**  
Remarks:

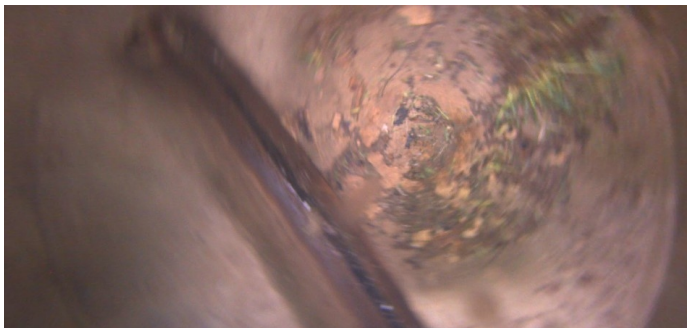
Code: **MGO**  
Description: **General Observation**

Distance (ft): **5.7**  
Structural Grade: **0**  
O&M Grade: **0**  
Clock Start/From:  
Clock To:  
1st Value:  
2nd Value:  
Value Percent:  
Step: **NO**  
Remarks: **Ins. Comp.**
