Manhole Inspection Report

Date:	04/21/2018	Weather:		Coding:	RZMACP
MH#:	M-806-040	Owner:	NA	Len. Surveyed:	6.8
P.O.#:		Surveyor:	John Kuglmaier	Rim to Invert:	7.4
Customer:		Cert. #:	U-1215-07002349	Wall Material:	Concrete (reinforced)

Street:	10th St. 132' West of Hobart Rd.	Project:	Hobart, IN
City:	Hobart, IN	GPS Northing:	0.0
Location:		GPS Easting:	0.0
Drain Area:	Southeast	GPS Accuracy:	Nearest Meter
Cover Shape:	Circular	Evidence of Surcharge:	No
Cover Size:	22.5	Potential for Runoff:	None
Comments:

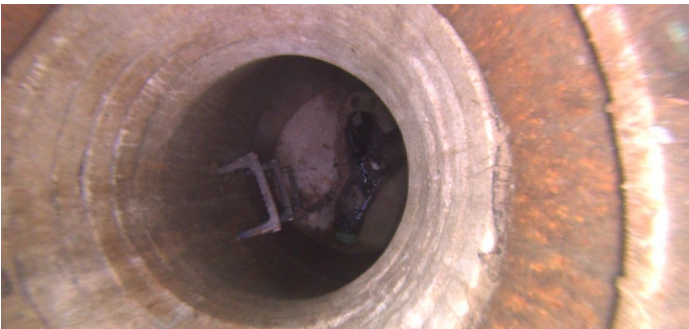
Code: **MGP**
 Description: **General Photo**

Distance (ft): **.0**
 Structural Grade: **0**
 O&M Grade: **0**
 Clock Start/From:
 Clock To:
 1st Value:
 2nd Value:
 Value Percent:
 Step: **NO**
 Remarks:

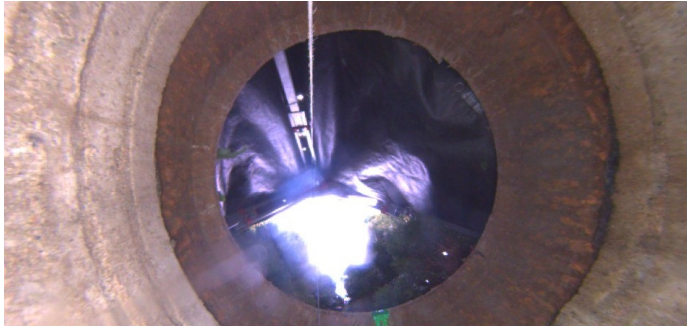
Code: **MGP**
Description: **General Photo**

Distance (ft): **2.4**
Structural Grade: **0**
O&M Grade: **0**
Clock Start/From:
Clock To:
1st Value:
2nd Value:
Value Percent:
Step: **NO**
Remarks:

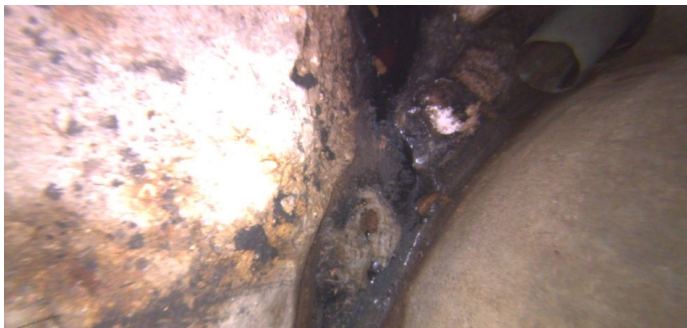
Code: **MGO**
Description: **General Observation**

Distance (ft): **5.7**
Structural Grade: **0**
O&M Grade: **0**
Clock Start/From:
Clock To:
1st Value:
2nd Value:
Value Percent:
Step: **NO**
Remarks: **Ins. Comp.**
