Manhole Inspection Report

Date:	04/21/2018	Weather:		Coding:	RZMACP
MH#:	M-806-042	Owner:	NA	Len. Surveyed:	4.5
P.O.#:		Surveyor:	John Kuglmaier	Rim to Invert:	4.7
Customer:	8.7	Cert. #:	U-1215-07002349	Wall Material:	Concrete (reinforced)

Street:	10th St. 176' East of Hobart Rd.	Project:	Hobart, IN
City:	Hobart, IN	GPS Northing:	0.0
Location:		GPS Easting:	0.0
Drain Area:	Southeast	GPS Accuracy:	Nearest Meter
Cover Shape:	Circular	Evidence of Surcharge:	No
Cover Size:	22.5	Potential for Runoff:	None
Comments:

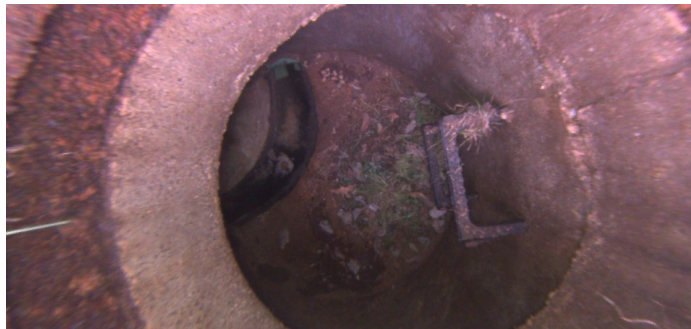
Code: **MGP**
Description: **General Photo**

Distance (ft): **.0**
Structural Grade: **0**
O&M Grade: **0**
Clock Start/From:
Clock To:
1st Value:
2nd Value:
Value Percent:
Step: **NO**
Remarks:

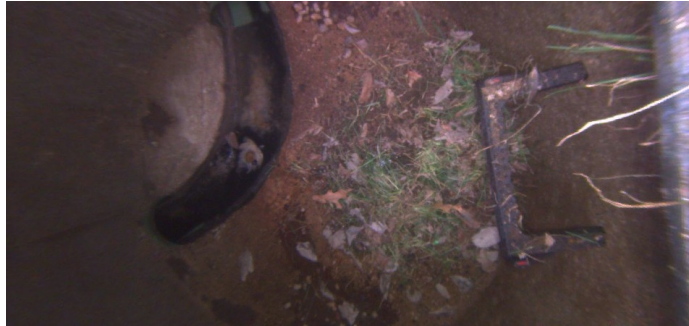
Code: **DAZ**
Description: **Deposits Attached Other**

Distance (ft): **2.0**
Structural Grade: **0**
O&M Grade: **2**
Clock Start/From: **12**
Clock To: **12**
1st Value:
2nd Value:
Value Percent: **10.000**
Step: **NO**
Remarks: **Mixed materials**

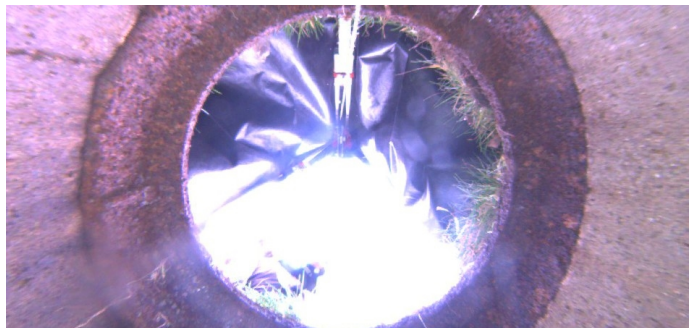
Code: **MGP**
Description: **General Photo**

Distance (ft): **2.3**
Structural Grade: **0**
O&M Grade: **0**
Clock Start/From:
Clock To:
1st Value:
2nd Value:
Value Percent:
Step: **NO**
Remarks:

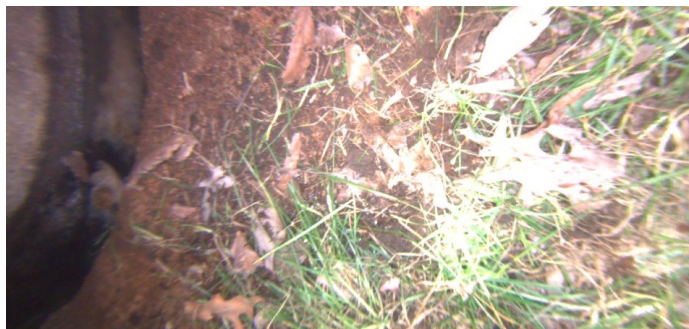
Code: **MGO**
Description: **General Observation**

Distance (ft): **3.8**
Structural Grade: **0**
O&M Grade: **0**
Clock Start/From:
Clock To:
1st Value:
2nd Value:
Value Percent:
Step: **NO**
Remarks: **Ins. Comp.**
