Manhole Inspection Report

| MH#: | M-806-043 | Owner: | NA | Len. Surveyed: | 5.3 |

| Street: | 10th St. 176' East of Hobart Rd. | Project: | Hobart, IN |

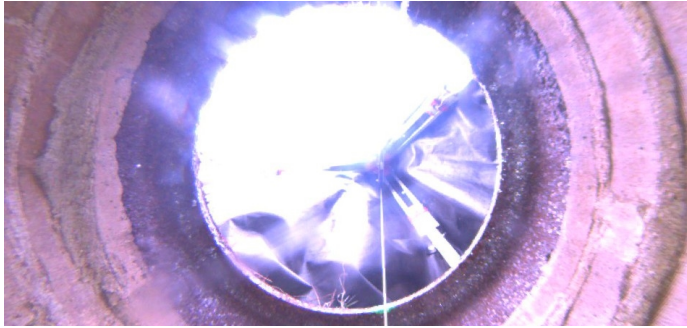
Code: **MGP**
Description: **General Photo**

Distance (ft): **2.3**
Structural Grade: **0**
O&M Grade: **0**
Clock Start/From:
Clock To:
1st Value:
2nd Value:
Value Percent:
Step: **NO**
Remarks:

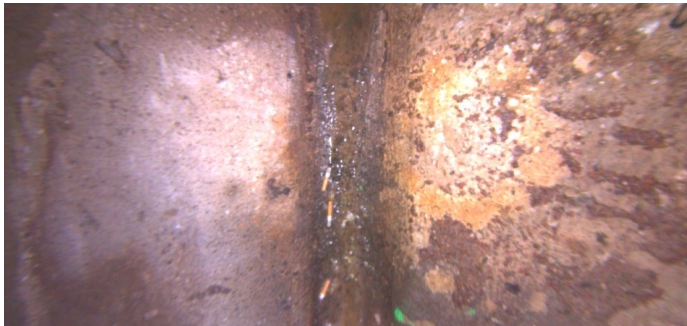
Code: **MGO**
Description: **General Observation**

Distance (ft): **4.6**
Structural Grade: **0**
O&M Grade: **0**
Clock Start/From:
Clock To:
1st Value:
2nd Value:
Value Percent:
Step: **NO**
Remarks: **Ins. Comp.**
