Manhole Inspection Report

Date:	04/21/2018	Weather:		Coding:	RZMACP
MH#:	M-806-044	Owner:	NA	Len. Surveyed:	6.3
P.O.#:		Surveyor:	John Kuglmaier	Rim to Invert:	6.8
Customer:		Cert. #:	U-1215-07002349	Wall Material:	Concrete (reinforced)

Street:	10th St. and Hobart Rd. 362' to the	Project:	Hobart, IN
City:	Hobart, IN	GPS Northing:	0.0
Location:		GPS Easting:	0.0
Drain Area:	Southeast	GPS Accuracy:	Nearest Meter
Cover Shape:	Circular	Evidence of Surcharge:	No
Cover Size:	22.5	Potential for Runoff:	None
Comments:

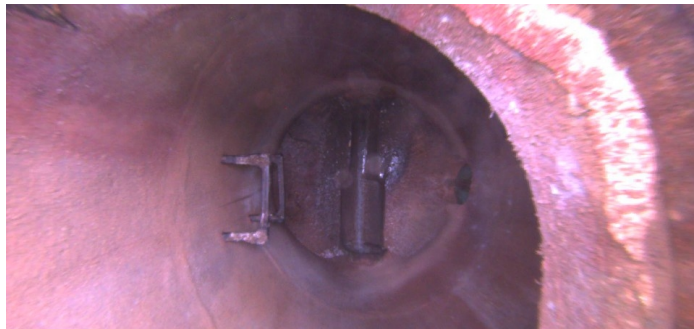
Code: **MGP**
Description: **General Photo**

Distance (ft): **.0**
Structural Grade: **0**
O&M Grade: **0**
Clock Start/From:
Clock To:
1st Value:
2nd Value:
Value Percent:
Step: **NO**
Remarks:

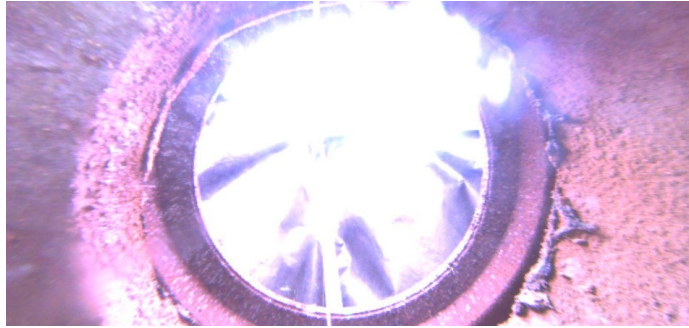
Code: **MGP**
Description: **General Photo**

Distance (ft): **2.3**
Structural Grade: **0**
O&M Grade: **0**
Clock Start/From:
Clock To:
1st Value:
2nd Value:
Value Percent:
Step: **NO**
Remarks:

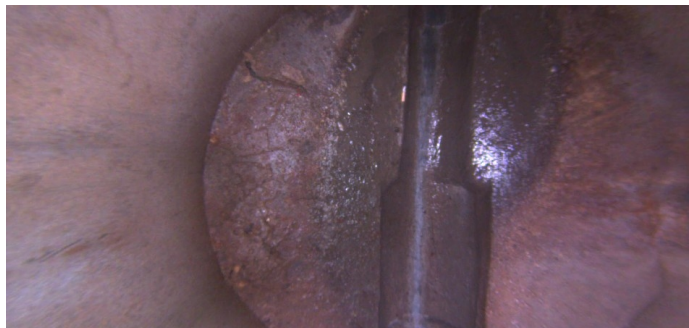
Code: **DSF**
Description: **Deposits Settled Fine**

Distance (ft): **4.3**
Structural Grade: **0**
O&M Grade: **2**
Clock Start/From: **8**
Clock To: **10**
1st Value:
2nd Value:
Value Percent: **5.000**
Step: **NO**
Remarks:

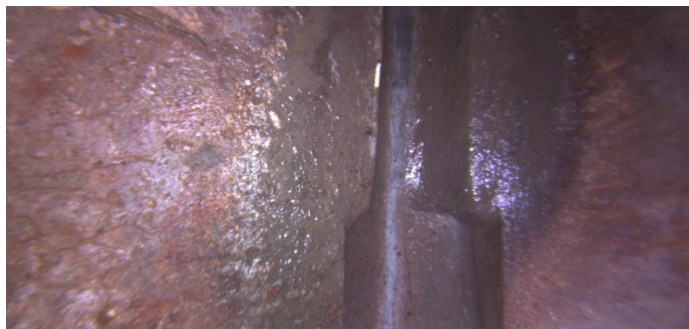
Code: **MGO**
Description: **General Observation**

Distance (ft): **5.4**
Structural Grade: **0**
O&M Grade: **0**
Clock Start/From:
Clock To:
1st Value:
2nd Value:
Value Percent:
Step: **NO**
Remarks: **Ins. Comp.**
