Manhole Inspection Report

Date:	04/21/2018	Weather:		Coding:	RZMACP
MH#:	M-806-047	Owner:	NA	Len. Surveyed:	8.9
P.O.#:		Surveyor:	John Kuglmaier	Rim to Invert:	9.3
Customer:		Cert. #:	U-1215-07002349	Wall Material:	Concrete (reinforced)

Street:	10th St. 47' West of Luther St.	Project:	Hobart, IN
City:	Hobart, IN	GPS Northing:	0.0
Location:		GPS Easting:	0.0
Drain Area:	Southeast	GPS Accuracy:	Nearest Meter
Cover Shape:	Circular	Evidence of Surcharge:	No
Cover Size:	22.5	Potential for Runoff:	None
Comments:

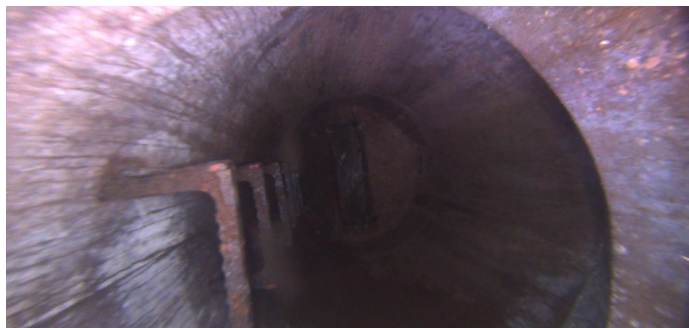
Code: **MGP**
Description: **General Photo**

Distance (ft): **.0**
Structural Grade: **0**
O&M Grade: **0**
Clock Start/From:
Clock To:
1st Value:
2nd Value:
Value Percent:
Step: **NO**
Remarks:

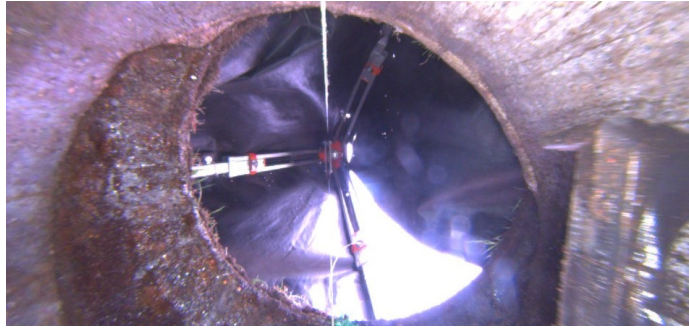
Code: **MGP**
Description: **General Photo**

Distance (ft): **2.1**
Structural Grade: **0**
O&M Grade: **0**
Clock Start/From:
Clock To:
1st Value:
2nd Value:
Value Percent:
Step: **NO**
Remarks:

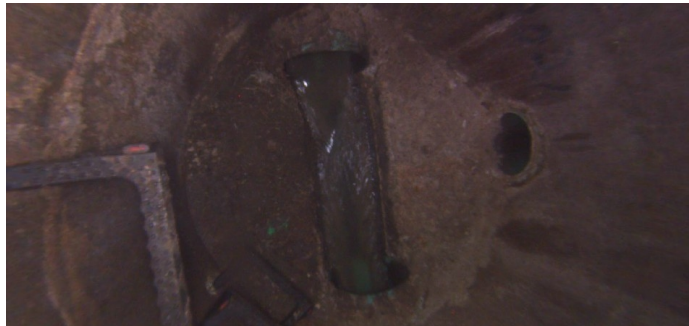
Code: **DAZ**
Description: **Deposits Attached Other**

Distance (ft): **5.4**
Structural Grade: **0**
O&M Grade: **2**
Clock Start/From: **12**
Clock To: **12**
1st Value:
2nd Value:
Value Percent: **10.000**
Step: **NO**
Remarks: **Mixed materials**

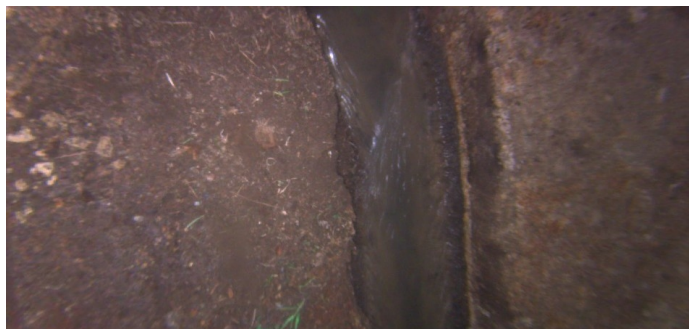
Code: **MGO**
Description: **General Observation**

Distance (ft): **7.7**
Structural Grade: **0**
O&M Grade: **0**
Clock Start/From:
Clock To:
1st Value:
2nd Value:
Value Percent:
Step: **NO**
Remarks: **Ins. Comp.**
