Manhole Inspection Report

Date:	04/21/2018	Weather:		Coding:	RZMACP
MH#:	M-806-050	Owner:	NA	Len. Surveyed:	3.8
P.O.#:		Surveyor:	John Kuglmaier	Rim to Invert:	4.0
Customer:		Cert. #:	U-1215-07002349	Wall Material:	Concrete (reinforced)

Street:	378' East of Springdale Dr. 513' Nort	Project:	Hobart, IN
City:	Hobart, IN	GPS Northing:	0.0
Location:		GPS Easting:	0.0
Drain Area:	Southeast	GPS Accuracy:	Nearest Meter
Cover Shape:	Circular	Evidence of Surcharge:	No
Cover Size:	22.5	Potential for Runoff:	None
Comments:

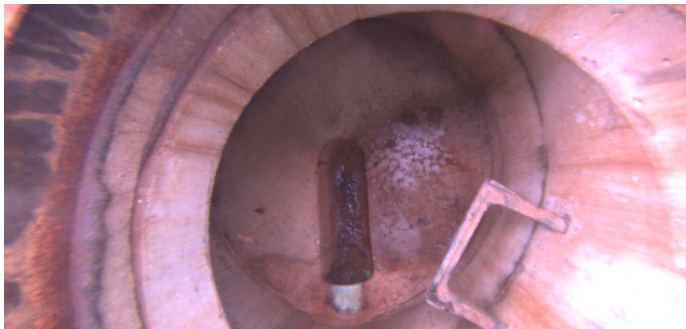
Code:	MGP
Description:	General Photo

Distance (ft):	.0
Structural Grade:	0
O&M Grade:	0
Clock Start/From:	
Clock To:	
1st Value:	
2nd Value:	
Value Percent:	
Step:	NO
Remarks:

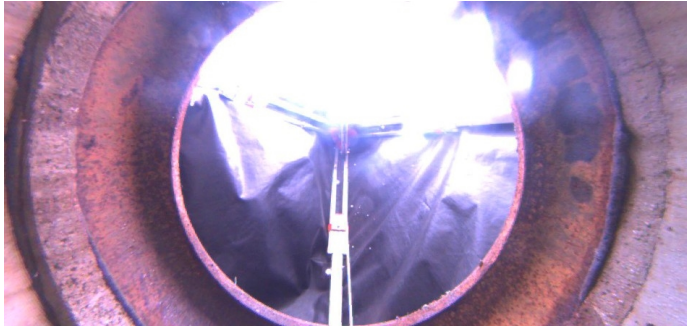
Code: **MGP**
Description: **General Photo**

Distance (ft): **1.9**
Structural Grade: **0**
O&M Grade: **0**
Clock Start/From:
Clock To:
1st Value:
2nd Value:
Value Percent:
Step: **NO**
Remarks:

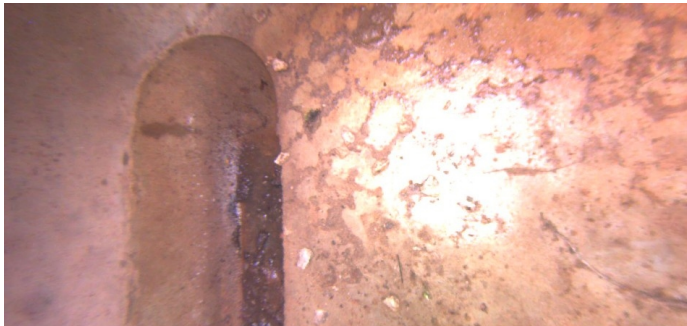
Code: **MGO**
Description: **General Observation**

Distance (ft): **3.3**
Structural Grade: **0**
O&M Grade: **0**
Clock Start/From:
Clock To:
1st Value:
2nd Value:
Value Percent:
Step: **NO**
Remarks: **Ins. Comp.**
