Manhole Inspection Report

Date:	04/21/2018	Weather:		Coding:	RZMACP
MH#:	M-806-052	Owner:	NA	Len. Surveyed:	6.7
P.O.#:		Surveyor:	John Kuglmaier	Rim to Invert:	6.9
Customer:		Cert. #:	U-1215-07002349	Wall Material:	Concrete (reinforced)

Street:	371' East of Springdale Dr. 183' Nort	Project:	Hobart, IN
City:	Hobart, IN	GPS Northing:	0.0
Location:		GPS Easting:	0.0
Drain Area:	Southeast	GPS Accuracy:	Nearest Meter
Cover Shape:	Circular	Evidence of Surcharge:	No
Cover Size:	22.5	Potential for Runoff:	None
Comments:

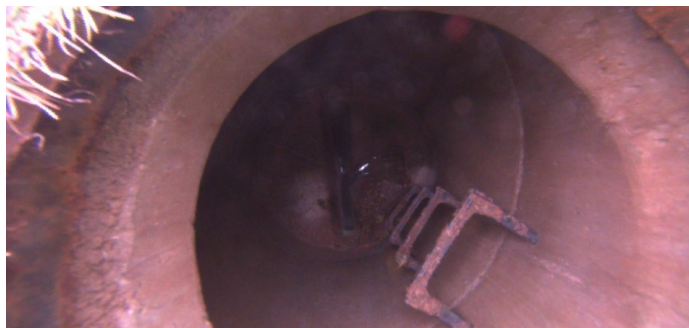
Code: **MGP**
Description: **General Photo**

Distance (ft): **.0**
Structural Grade: **0**
O&M Grade: **0**
Clock Start/From:
Clock To:
1st Value:
2nd Value:
Value Percent:
Step: **NO**
Remarks:

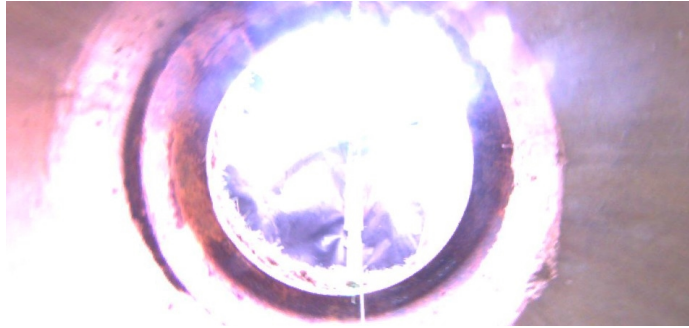
Code:	MGP
Description:	General Photo
Distance (ft):	2.6
Structural Grade:	0
O&M Grade:	0
Clock Start/From:	
Clock To:	
1st Value:	
2nd Value:	
Value Percent:	
Step:	NO
Remarks:

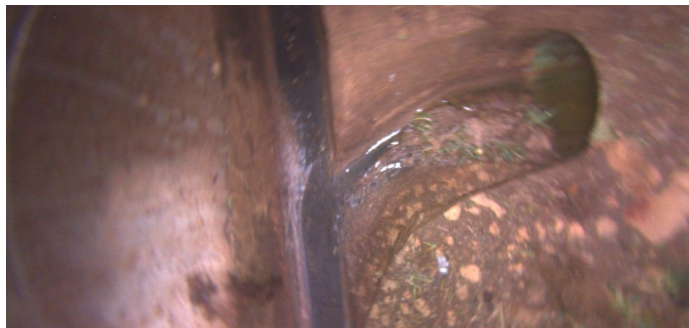
Code:	MGO
Description:	General Observation
Distance (ft):	5.7
Structural Grade:	0
O&M Grade:	0
Clock Start/From:	
Clock To:	
1st Value:	
2nd Value:	
Value Percent:	
Step:	NO
Remarks:	Ins. Comp.
