# Manhole Inspection Report

Date:	04/21/2018	Weather:		Coding:	RZMACP
MH#:	M-806-053	Owner:	NA	Len. Surveyed:	7.7
P.O.#:		Surveyor:	John Kuglmaier	Rim to Invert:	8.1
Customer:		Cert. #:	U-1215-07002349	Wall Material:	Concrete (reinforced)

Street:	365' East of Springdale Dr. 57' North	Project:	Hobart, IN
City:	Hobart, IN	GPS Northing:	0.0
Location:		GPS Easting:	0.0
Drain Area:	Southeast	GPS Accuracy:	Nearest Meter
Cover Shape:	Circular	Evidence of Surcharge:	No
Cover Size:	22.5	Potential for Runoff:	None
Comments:

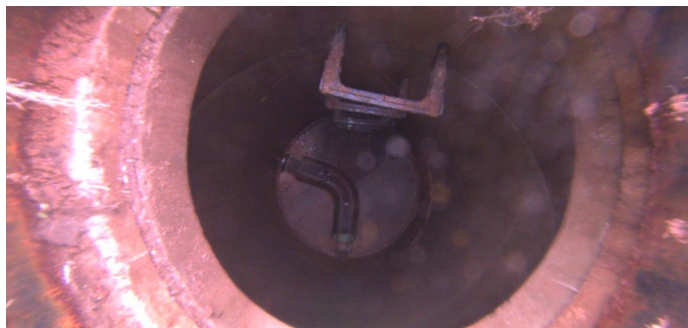
Code: **MGP**  
Description: **General Photo**

Distance (ft): **.0**  
Structural Grade: **0**  
O&M Grade: **0**  
Clock Start/From:  
Clock To:  
1st Value:  
2nd Value:  
Value Percent:  
Step: **NO**  
Remarks:

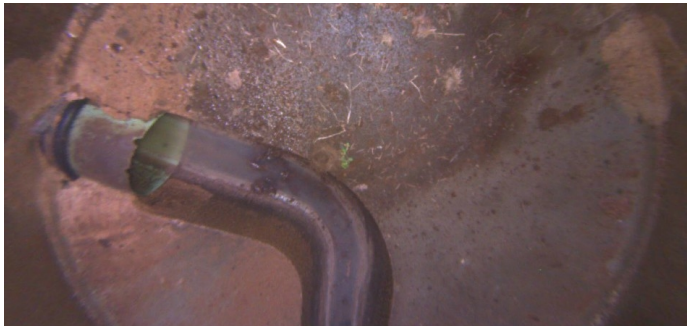
Code: **MGO**  
Description: **General Observation**

Distance (ft): **6.4**  
Structural Grade: **0**  
O&M Grade: **0**  
Clock Start/From:  
Clock To:  
1st Value:  
2nd Value:  
Value Percent:  
Step: **NO**  
Remarks: **Ins. Comp.**
