Manhole Inspection Report

Date:	04/21/2018	Weather:		Coding:	RZMACP
MH#:	M-806-054	Owner:	NA	Len. Surveyed:	4.4
P.O.#:		Surveyor:	John Kuglmaier	Rim to Invert:	4.3
Customer:		Cert. #:	U-1215-07002349	Wall Material:	Concrete (reinforced)

Street:	518' East of Springdale Dr. 512' Nort	Project:	Hobart, IN
City:	Hobart, IN	GPS Northing:	0.0
Location:		GPS Easting:	0.0
Drain Area:	Southeast	GPS Accuracy:	Nearest Meter
Cover Shape:	Circular	Evidence of Surcharge:	No
Cover Size:	22.5	Potential for Runoff:	None
Comments:

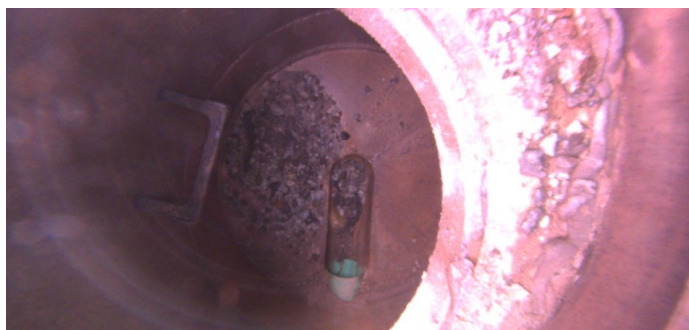
Code: **MGP**
Description: **General Photo**

Distance (ft): **.0**
Structural Grade: **0**
O&M Grade: **0**
Clock Start/From:
Clock To:
1st Value:
2nd Value:
Value Percent:
Step: **NO**
Remarks:

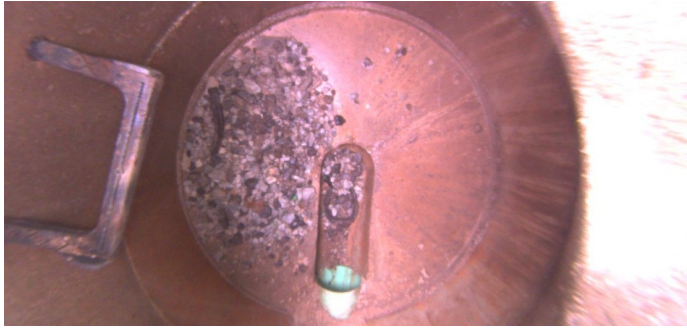
Code: **DSGV**
Description: **Deposits Settled Gravel**

Distance (ft): **1.0**
Structural Grade: **0**
O&M Grade: **2**
Clock Start/From: **7**
Clock To: **11**
1st Value:
2nd Value:
Value Percent: **5.000**
Step: **NO**
Remarks:

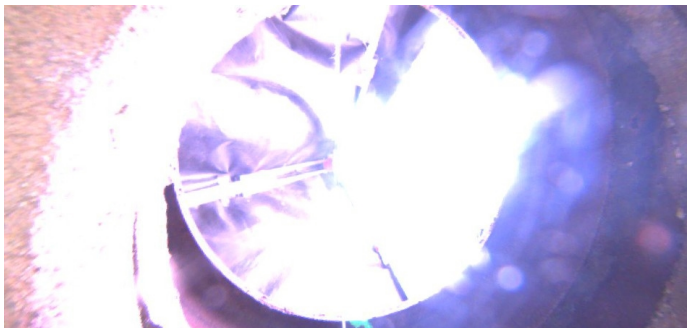
Code: **MGP**
Description: **General Photo**

Distance (ft): **2.1**
Structural Grade: **0**
O&M Grade: **0**
Clock Start/From:
Clock To:
1st Value:
2nd Value:
Value Percent:
Step: **NO**
Remarks:

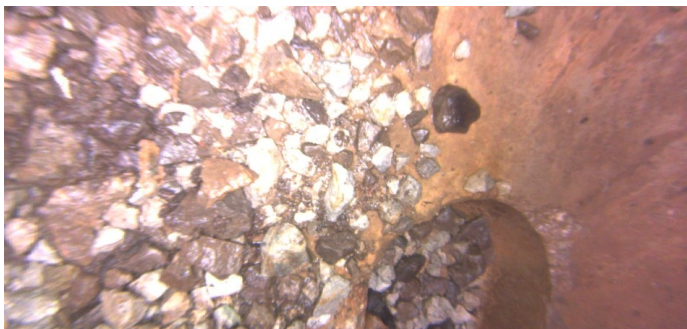
Code: **MGO**
Description: **General Observation**

Distance (ft): **3.8**
Structural Grade: **0**
O&M Grade: **0**
Clock Start/From:
Clock To:
1st Value:
2nd Value:
Value Percent:
Step: **NO**
Remarks: **Ins. Comp.**
