Manhole Inspection Report

Date:	04/21/2018	Weather:		Coding:	RZMACP
MH#:	M-806-056	Owner:	NA	Len. Surveyed:	4.2
P.O.#:		Surveyor:	John Kuglmaier	Rim to Invert:	4.2
Customer:		Cert. #:	U-1215-07002349	Wall Material:	Concrete (reinforced)

Street:	751' East of Springdale Dr. 601' Nort	Project:	Hobart, IN
City:	Hobart, IN	GPS Northing:	0.0
Location:		GPS Easting:	0.0
Drain Area:	Southeast	GPS Accuracy:	Nearest Meter
Cover Shape:	Circular	Evidence of Surcharge:	No
Cover Size:	22.5	Potential for Runoff:	None
Comments:

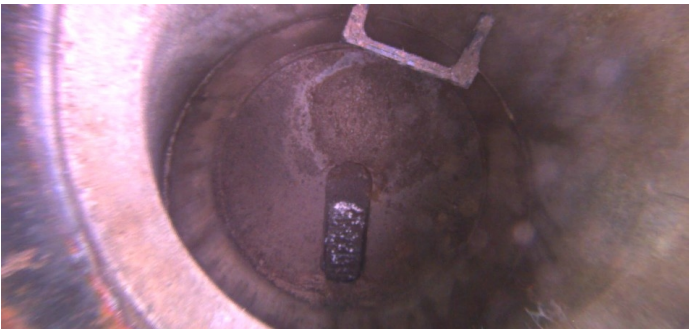
Code: **MGP**
Description: **General Photo**

Distance (ft): **.0**
Structural Grade: **0**
O&M Grade: **0**
Clock Start/From:
Clock To:
1st Value:
2nd Value:
Value Percent:
Step: **NO**
Remarks:

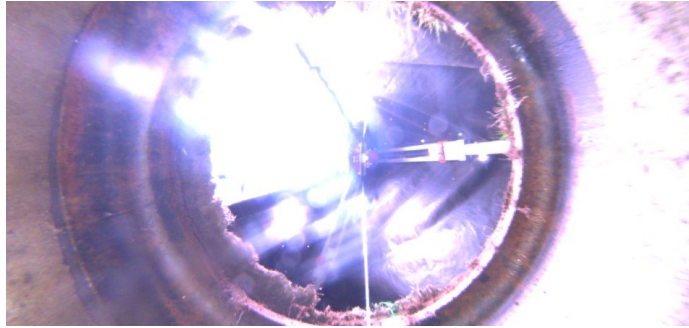
Code: **MGP**
Description: **General Photo**

Distance (ft): **2.1**
Structural Grade: **0**
O&M Grade: **0**
Clock Start/From:
Clock To:
1st Value:
2nd Value:
Value Percent:
Step: **NO**
Remarks:

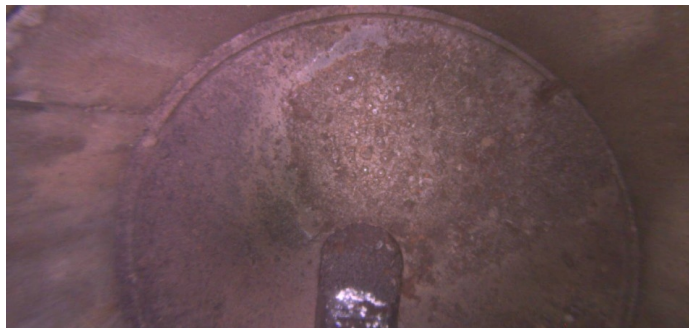
Code: **DSF**
Description: **Deposits Settled Fine**

Distance (ft): **2.3**
Structural Grade: **0**
O&M Grade: **2**
Clock Start/From: **9**
Clock To: **3**
1st Value:
2nd Value:
Value Percent: **5.000**
Step: **NO**
Remarks:

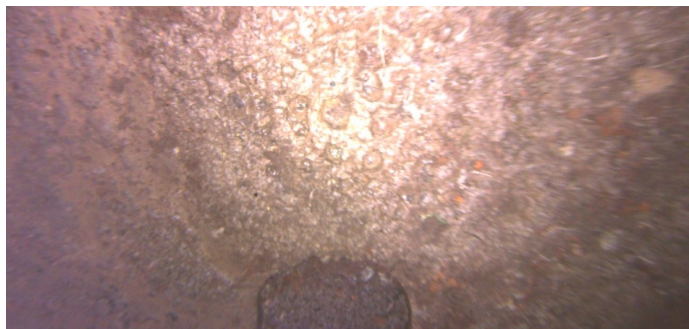
Code: **MGO**
Description: **General Observation**

Distance (ft): **3.5**
Structural Grade: **0**
O&M Grade: **0**
Clock Start/From:
Clock To:
1st Value:
2nd Value:
Value Percent:
Step: **NO**
Remarks: **Ins. Comp.**
