Manhole Inspection Report

Date:	04/21/2018	Weather:		Coding:	RZMACP
MH#:	M-806-057	Owner:	NA	Len. Surveyed:	5.4
P.O.#:		Surveyor:	John Kuglmaier	Rim to Invert:	5.4
Customer:		Cert. #:	U-1215-07002349	Wall Material:	Concrete (reinforced)

Street:	751' East of Springdale Dr. 485' Nort	Project:	Hobart, IN
City:	Hobart, IN	GPS Northing:	0.0
Location:		GPS Easting:	0.0
Drain Area:	Southeast	GPS Accuracy:	Nearest Meter
Cover Shape:	Circular	Evidence of Surcharge:	No
Cover Size:	22.5	Potential for Runoff:	None
Comments:

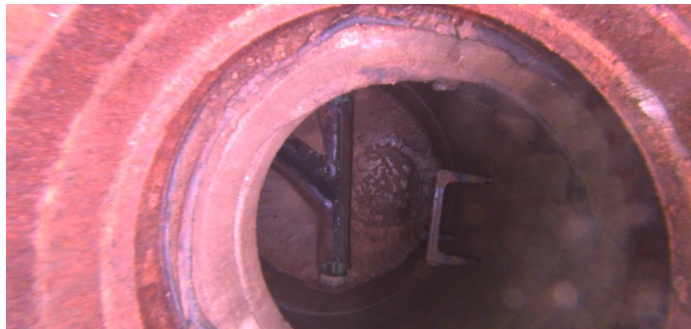
Code: **MGP**
Description: **General Photo**

Distance (ft): **.0**
Structural Grade: **0**
O&M Grade: **0**
Clock Start/From:
Clock To:
1st Value:
2nd Value:
Value Percent:
Step: **NO**
Remarks:

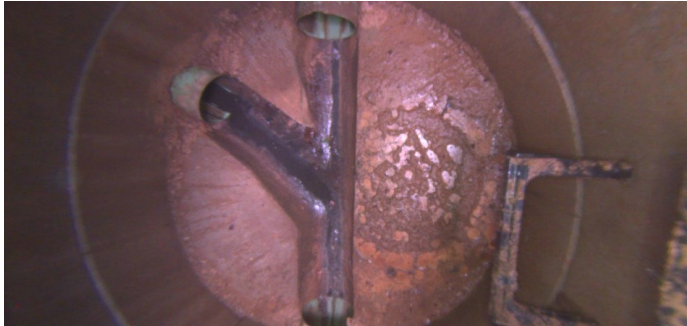
Code: **DSF**
Description: **Deposits Settled Fine**

Distance (ft): **2.4**
Structural Grade: **0**
O&M Grade: **2**
Clock Start/From: **12**
Clock To: **6**
1st Value:
2nd Value:
Value Percent: **5.000**
Step: **NO**
Remarks:

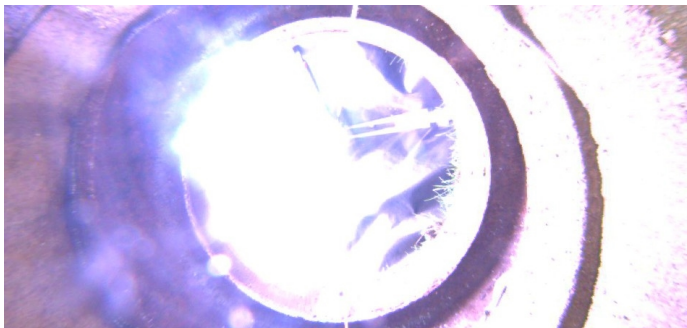
Code: **MGP**
Description: **General Photo**

Distance (ft): **2.7**
Structural Grade: **0**
O&M Grade: **0**
Clock Start/From:
Clock To:
1st Value:
2nd Value:
Value Percent:
Step: **NO**
Remarks:

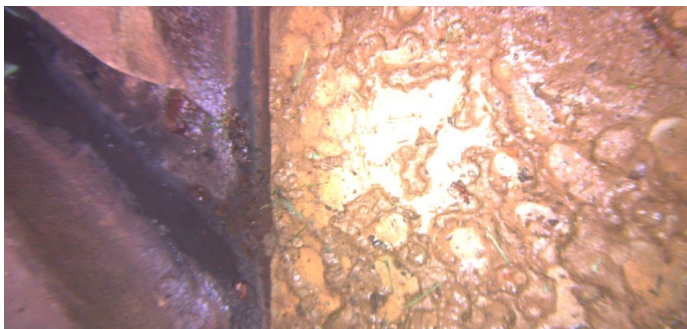
Code: **MGO**
Description: **General Observation**

Distance (ft): **4.7**
Structural Grade: **0**
O&M Grade: **0**
Clock Start/From:
Clock To:
1st Value:
2nd Value:
Value Percent:
Step: **NO**
Remarks: **Ins. Comp.**
