Manhole Inspection Report

Date:	04/21/2018	Weather:		Coding:	RZMACP
MH#:	M-806-058	Owner:	NA	Len. Surveyed:	8.5
P.O.#:		Surveyor:	John Kuglmaier	Rim to Invert:	8.3
Customer:		Cert. #:	U-1215-07002349	Wall Material:	Concrete (reinforced)

Street:	744' East of Springdale Dr. 293' Nort	Project:	Hobart, IN
City:	Hobart, IN	GPS Northing:	0.0
Location:		GPS Easting:	0.0
Drain Area:	Southeast	GPS Accuracy:	Nearest Meter
Cover Shape:	Circular	Evidence of Surcharge:	Yes
Cover Size:	22.5	Potential for Runoff:	None
Comments:

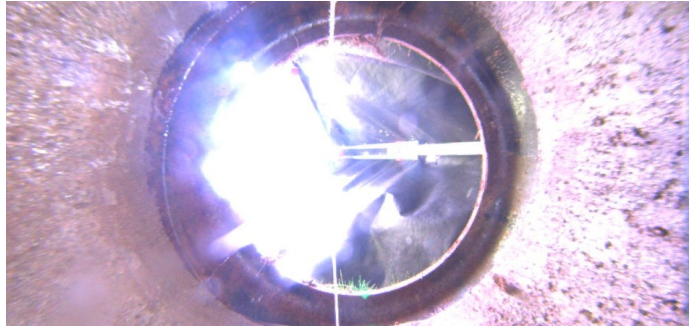
Code: **MGP**
Description: **General Photo**

Distance (ft): **3.0**
Structural Grade: **0**
O&M Grade: **0**
Clock Start/From:
Clock To:
1st Value:
2nd Value:
Value Percent:
Step: **NO**
Remarks:

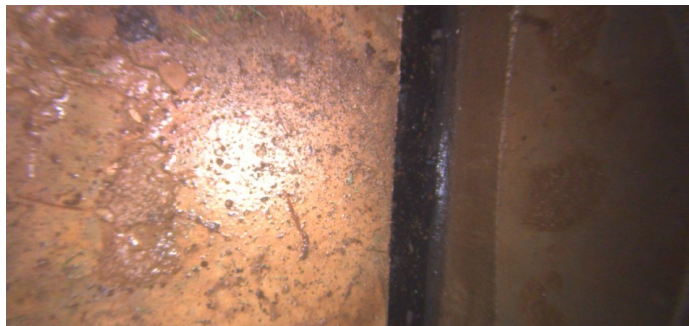
Code: **MGO**
Description: **General Observation**

Distance (ft): **7.4**
Structural Grade: **0**
O&M Grade: **0**
Clock Start/From:
Clock To:
1st Value:
2nd Value:
Value Percent:
Step: **NO**
Remarks: **Ins. Comp.**
