# Manhole Inspection Report

Date:	04/21/2018	Weather:		Coding:	RZMACP
MH#:	M-806-059	Owner:	NA	Len. Surveyed:	5.9
P.O.#:		Surveyor:	John Kuglmaier	Rim to Invert:	6.4
Customer:		Cert. #:	U-1215-07002349	Wall Material:	Concrete (reinforced)

Street:	28' South of 10th St. 191' West of D	Project:	Hobart, IN
City:	Hobart, IN	GPS Northing:	0.0
Location:		GPS Easting:	0.0
Drain Area:	Southeast	GPS Accuracy:	Nearest Meter
Cover Shape:	Circular	Evidence of Surcharge:	Yes
Cover Size:	22.5	Potential for Runoff:	None
Comments:

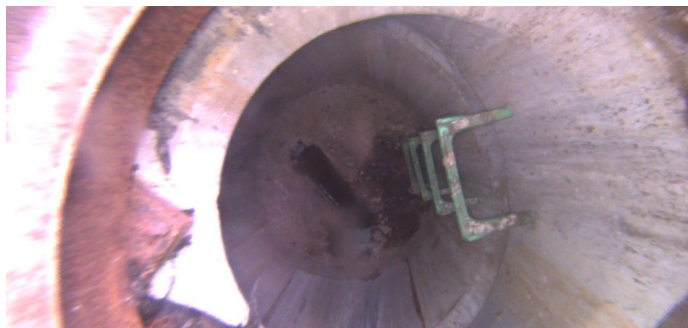
Code: **MGP**  
Description: **General Photo**

Distance (ft): **.0**  
Structural Grade: **0**  
O&M Grade: **0**  
Clock Start/From:  
Clock To:  
1st Value:  
2nd Value:  
Value Percent:  
Step: **NO**  
Remarks:

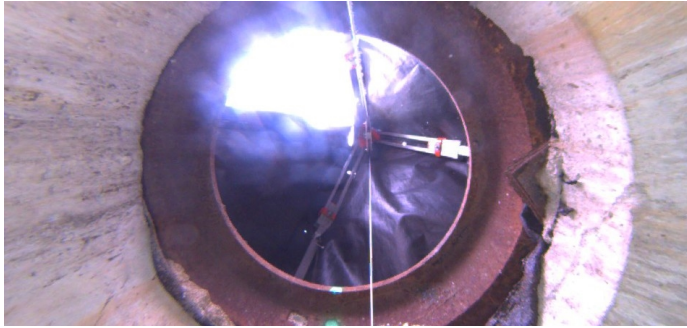
Code: **MGP**  
Description: **General Photo**

Distance (ft): **2.6**  
Structural Grade: **0**  
O&M Grade: **0**  
Clock Start/From:  
Clock To:  
1st Value:  
2nd Value:  
Value Percent:  
Step: **NO**  
Remarks:

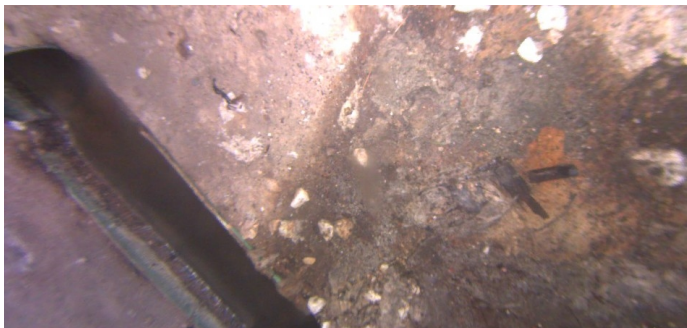
Code: **MGO**  
Description: **General Observation**

Distance (ft): **5.4**  
Structural Grade: **0**  
O&M Grade: **0**  
Clock Start/From:  
Clock To:  
1st Value:  
2nd Value:  
Value Percent:  
Step: **NO**  
Remarks: **Ins. Comp.**
