Manhole Inspection Report

Date:	04/21/2018	Weather:		Coding:	RZMACP
MH#:	M-806-061	Owner:	NA	Len. Surveyed:	9.5
P.O.#:		Surveyor:	John Kuglmaier	Rim to Invert:	9.7
Customer:		Cert. #:	U-1215-07002349	Wall Material:	Concrete (reinforced)

Street:	10th St. and Deer Cross Trail. To the	Project:	Hobart, IN
City:	Hobart, IN	GPS Northing:	0.0
Location:		GPS Easting:	0.0
Drain Area:	Southeast	GPS Accuracy:	Nearest Meter
Cover Shape:	Circular	Evidence of Surcharge:	No
Cover Size:	22.5	Potential for Runoff:	None
Comments:

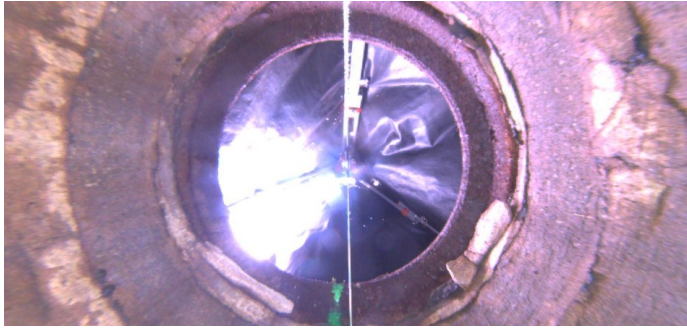
Code: **MGP**
Description: **General Photo**

Distance (ft): **2.7**
Structural Grade: **0**
O&M Grade: **0**
Clock Start/From:
Clock To:
1st Value:
2nd Value:
Value Percent:
Step: **NO**
Remarks:

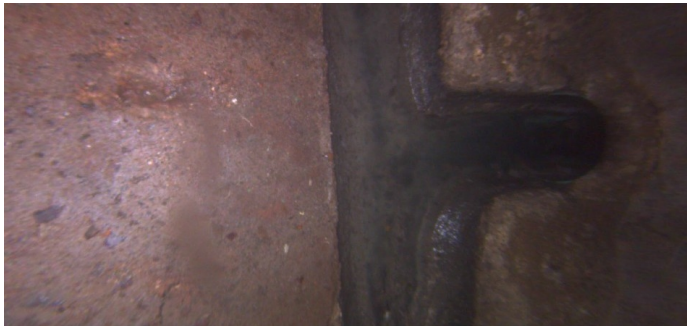
Code: **MGO**
Description: **General Observation**

Distance (ft): **8.3**
Structural Grade: **0**
O&M Grade: **0**
Clock Start/From:
Clock To:
1st Value:
2nd Value:
Value Percent:
Step: **NO**
Remarks: **Ins. Comp.**
