# Manhole Inspection Report

Street:	<b>On 10th St. 119' East of Starboard Ct</b>	Project:	<b>Hobart, IN</b>
City:	<b>Hobart, IN</b>	GPS Northing:	<b>0.0</b>
Location:		GPS Easting:	<b>0.0</b>
Drain Area:	<b>Southeast</b>	GPS Accuracy:	<b>Nearest Meter</b>
Cover Shape:	<b>Circular</b>	Evidence of Surcharge:	<b>Yes</b>
Cover Size:	<b>22.5</b>	Potential for Runoff:	<b>None</b>
Comments:

**M-806-062**

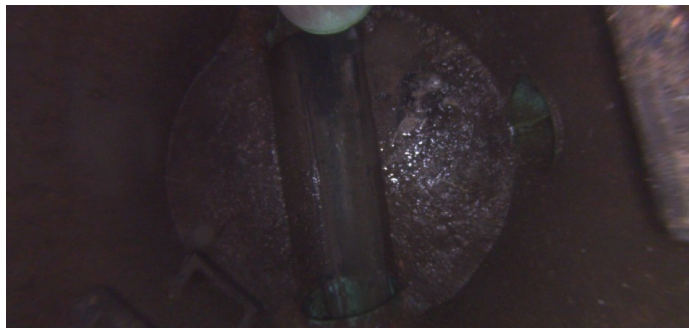
Code: **DAZ**  
Description: **Deposits Attached Other**

Distance (ft): **6.7**  
Structural Grade: **0**  
O&M Grade: **2**  
Clock Start/From: **12**  
Clock To: **12**  
1st Value:  
2nd Value:  
Value Percent: **5.000**  
Step: **NO**  
Remarks: **Mixed materials**

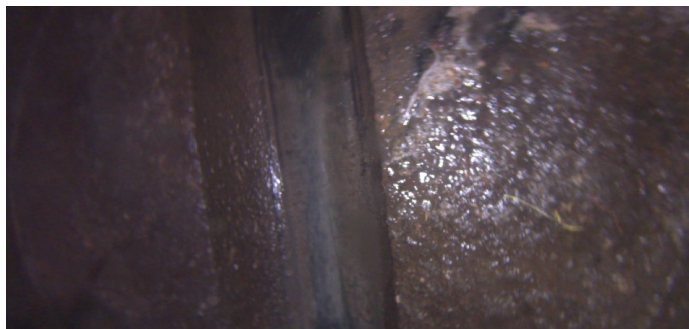
Code: **MGO**  
Description: **General Observation**

Distance (ft): **8.2**  
Structural Grade: **0**  
O&M Grade: **0**  
Clock Start/From:  
Clock To:  
1st Value:  
2nd Value:  
Value Percent:  
Step: **NO**  
Remarks: **Ins. Comp.**
