Manhole Inspection Report

| MH#: | M-806-063 | Owner: | NA | Len. Surveyed: | 10.3 |

| Street: | 28' South of 10th St. 72' East of Port | Project: | Hobart, IN |

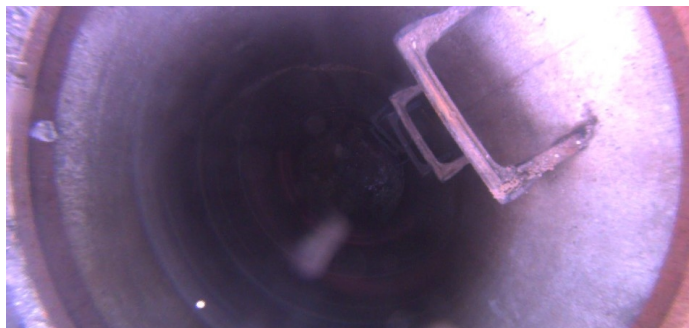
Code: **MGP**
Description: **General Photo**

Distance (ft): **.0**
Structural Grade: **0**
O&M Grade: **0**
Clock Start/From:
Clock To:
1st Value:
2nd Value:
Value Percent:
Step: **NO**
Remarks:

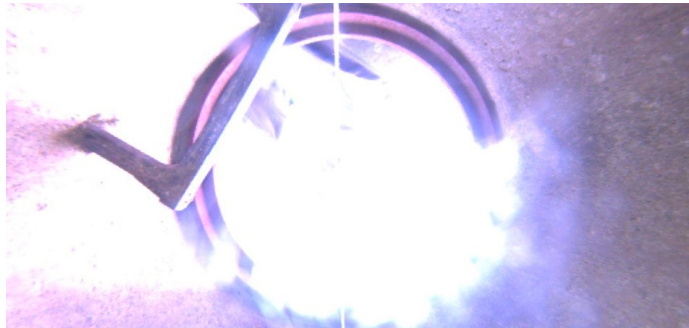
Code: **MGP**
Description: **General Photo**

Distance (ft): **3.0**
Structural Grade: **0**
O&M Grade: **0**
Clock Start/From:
Clock To:
1st Value:
2nd Value:
Value Percent:
Step: **NO**
Remarks:

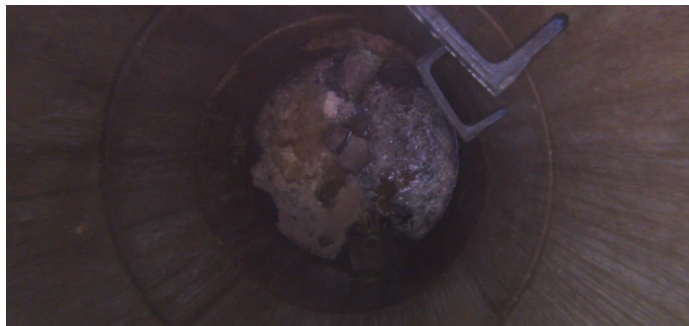
Code: **IS**
Description: **Infil Stain**

| | Position | Code | Observation | Video (sec) | Grade |
|--|---|---|---|---|---|
| | 5.3 | IS | Infil Stain | 48 | NA |

Distance (ft): **5.3**
Structural Grade: **0**
O&M Grade: **0**
Clock Start/From: **12**
Clock To: **12**
1st Value:
2nd Value:
Value Percent:
Step: **NO**
Remarks:

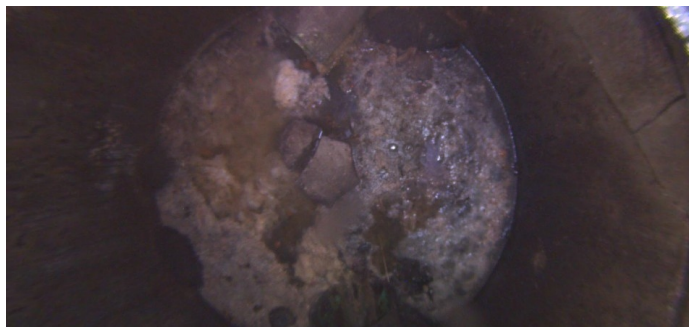
Code: **DAZ**
Description: **Deposits Attached Other**

| | Position | Code | Observation | Video (sec) | Grade |
|--|---|---|---|---|---|
| | 7.7 | DAZ | Deposits Attached Other | 64 | M 2 |

Distance (ft): **7.7**
Structural Grade: **0**
O&M Grade: **2**
Clock Start/From: **12**
Clock To: **12**
1st Value:
2nd Value:
Value Percent: **10.000**
Step: **NO**
Remarks: **Mixed materials**

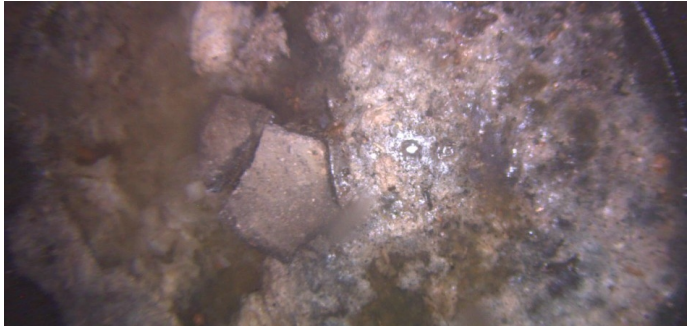
| Code: | MGO |

| Description: | General Observation |
| Distance (ft): | 9.2 |
| Remarks: | Ins. Comp. |
