Manhole Inspection Report

Date:	04/24/2018	Weather:		Coding:	RZMACP
MH#:	M-806-064	Owner:	NA	Len. Surveyed:	11.5
P.O.#:		Surveyor:	John Kuglmaier	Rim to Invert:	11.1
Customer:	8.7	Cert. #:	U-1215-07002349	Wall Material:	Concrete (reinforced)

M-806-064

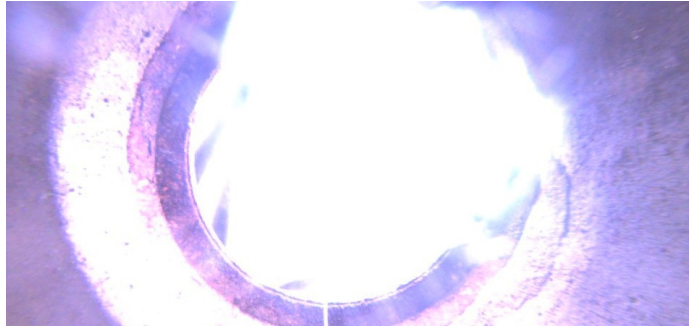
Code:	MGP
Description:	General Photo

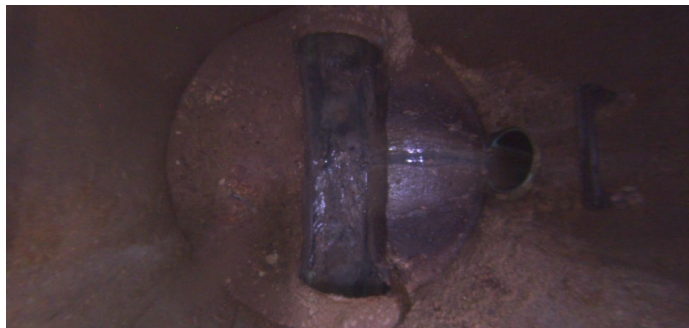
Code: **MGP**
Description: **General Photo**

Distance (ft): **2.8**
Structural Grade: **0**
O&M Grade: **0**
Clock Start/From:
Clock To:
1st Value:
2nd Value:
Value Percent:
Step: **NO**
Remarks:

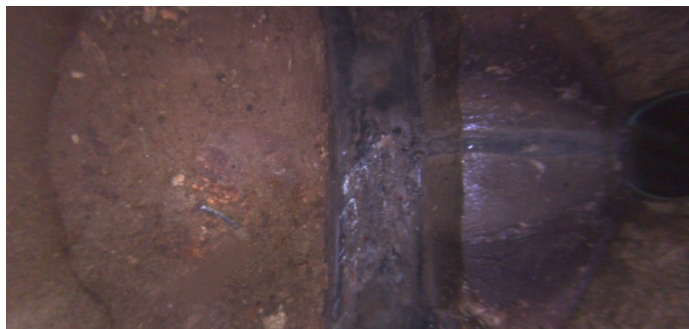
Code: **DSF**
Description: **Deposits Settled Fine**

Distance (ft): **8.3**
Structural Grade: **0**
O&M Grade: **2**
Clock Start/From: **6**
Clock To: **12**
1st Value:
2nd Value:
Value Percent: **5.000**
Step: **NO**
Remarks:
