Manhole Inspection Report

Date:	04/20/2018	Weather:		Coding:	RZMACP
MH#:	M-806-065	Owner:	NA	Len. Surveyed:	6.1
P.O.#:		Surveyor:	John Kuglmaier	Rim to Invert:	5.7
Customer:		Cert. #:	U-1215-07002349	Wall Material:	Concrete (reinforced)

Street:	On Gilbert Ct. 317' South of 6th St.	Project:	Hobart, IN
City:	Hobart, IN	GPS Northing:	2907995.487
Location:		GPS Easting:	2907995.487
Drain Area:	Southeast	GPS Accuracy:	Sub-Meter
Cover Shape:	Circular	Evidence of Surcharge:	No
Cover Size:	22.5	Potential for Runoff:	None
Comments:

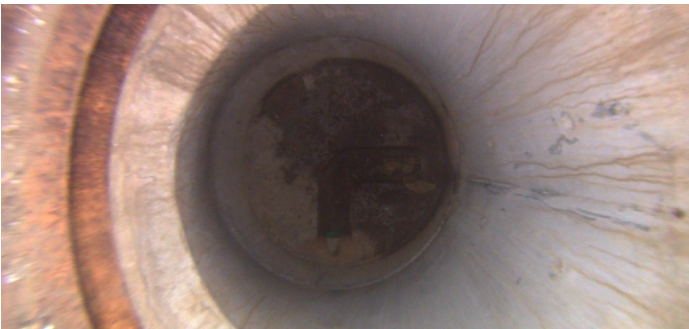
Code: **MGP**
 Description: **General Photo**
 Distance (ft): **.0**
 Structural Grade: **0**
 O&M Grade: **0**
 Clock Start/From:
 Clock To:
 1st Value:
 2nd Value:
 Value Percent:
 Step: **NO**
 Remarks:

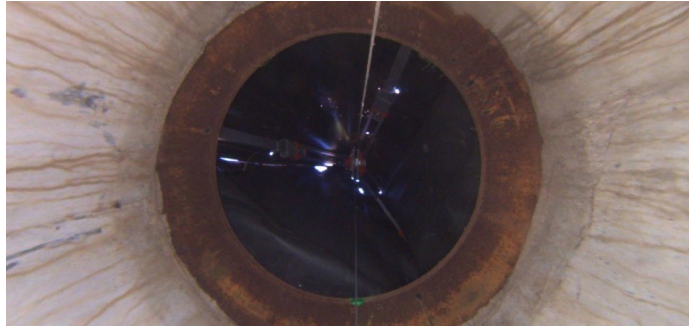
Code: **MGP**
Description: **General Photo**

Distance (ft): **2.6**
Structural Grade: **0**
O&M Grade: **0**
Clock Start/From:
Clock To:
1st Value:
2nd Value:
Value Percent:
Step: **NO**
Remarks:

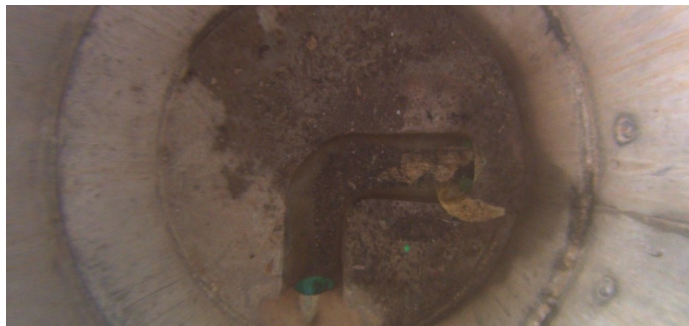
Code: **DAZ**
Description: **Deposits Attached Other**

Distance (ft): **2.8**
Structural Grade: **0**
O&M Grade: **2**
Clock Start/From: **12**
Clock To: **12**
1st Value:
2nd Value:
Value Percent: **5.000**
Step: **NO**
Remarks: **Mixed materials**

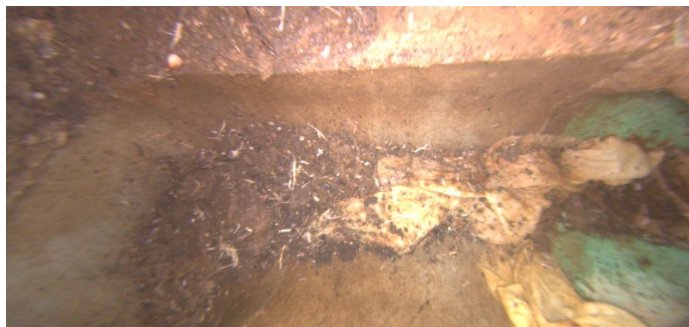
Code: **MGO**
Description: **General Observation**

Distance (ft): **5.2**
Structural Grade: **0**
O&M Grade: **0**
Clock Start/From:
Clock To:
1st Value:
2nd Value:
Value Percent:
Step: **NO**
Remarks: **Ins. Comp.**
