Manhole Inspection Report

Date:	04/17/2018	Weather:		Coding:	RZMACP
MH#:	M-807-004	Owner:	NA	Len. Surveyed:	10.1
P.O.#:		Surveyor:	Jen Costello	Rim to Invert:	10.4
Customer:		Cert. #:	U-907-5518	Wall Material:	Concrete (reinforced)

Street:	12th St. 345' East of Linda St.	Project:	Hobart, IN
City:	Hobart, IN	GPS Northing:	2907658.414
Location:		GPS Easting:	2907658.414
Drain Area:	Southeast	GPS Accuracy:	Sub-Meter
Cover Shape:	Circular	Evidence of Surcharge:	No
Cover Size:	22.5	Potential for Runoff:	None
Comments:

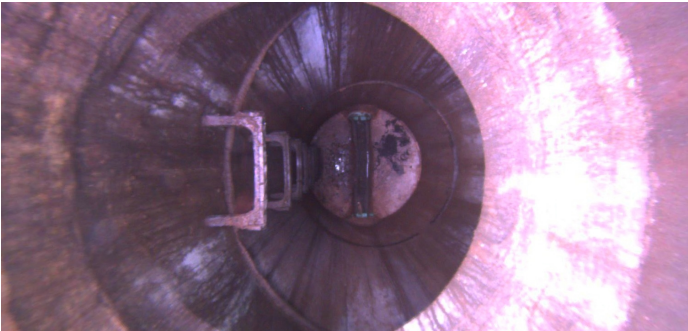
MGP

General Photo

access mh

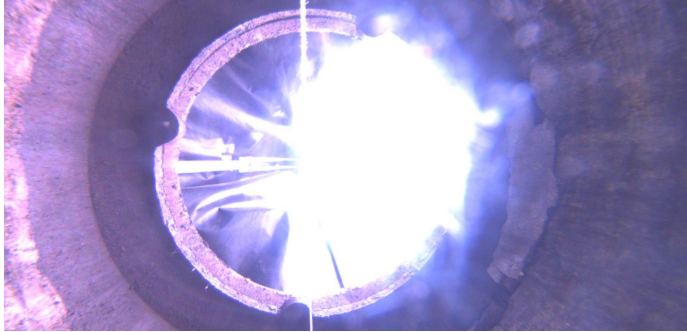
Code: **MGO**
Description: **General Observation**

Distance (ft): **1.8**
Structural Grade: **0**
O&M Grade: **0**
Clock Start/From:
Clock To:
1st Value:
2nd Value:
Value Percent:
Step: **NO**
Remarks: **underside of frame**

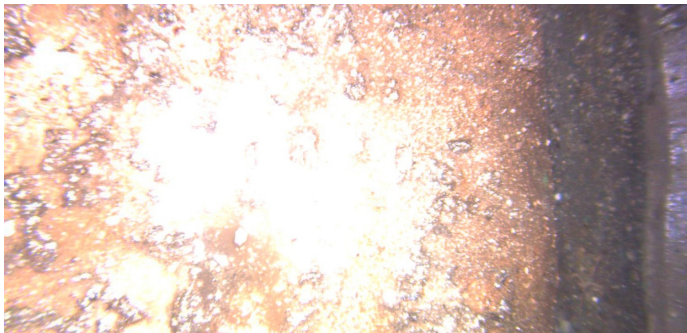
Code: **MGO**
Description: **General Observation**

Distance (ft): **10.1**
Structural Grade: **0**
O&M Grade: **0**
Clock Start/From:
Clock To:
1st Value:
2nd Value:
Value Percent:
Step: **NO**
Remarks: **end survey**
