Manhole Inspection Report

| MH#: | M-807-005 | Owner: | NA | Len. Surveyed: | 6.2 |

| Street: | Illinois St. 106' North of 14th St. | Project: | Hobart, IN |

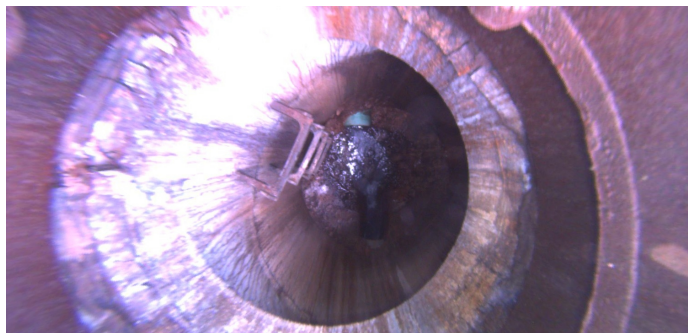
Code: **MGO**
Description: **General Observation**

Distance (ft): **.0**
Structural Grade: **0**
O&M Grade: **0**
Clock Start/From:
Clock To:
1st Value:
2nd Value:
Value Percent:
Step: **NO**
Remarks: **ACCESS MH**

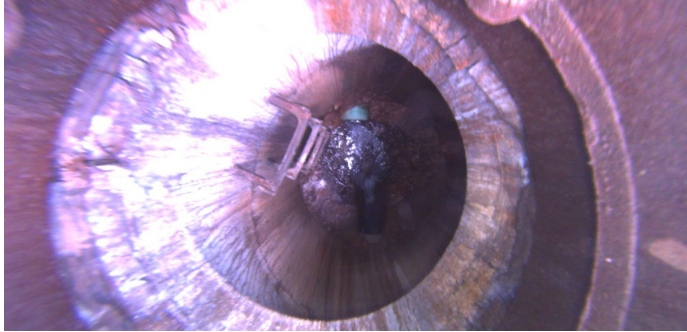
| Code: | RFJ |
| Description: | Roots Fine Joint |
| Distance (ft): | .0 |
| O&M Grade: | 1 |
| Clock Start/From: | 9 |
| Clock To: | 12 |

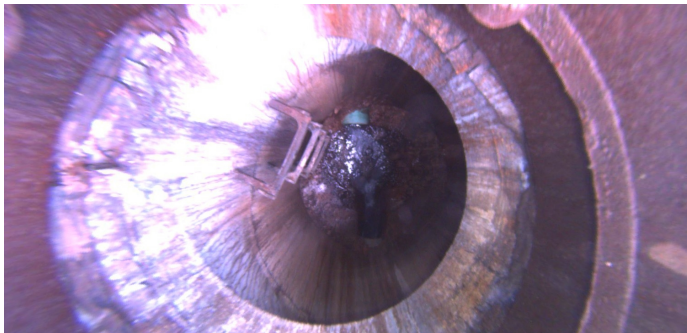
| Code: | FM |
| Description: | Fracture Multiple |
| Distance (ft): | .0 |
| Structural Grade: | 4 |
| Clock Start/From: | 12 |
| Clock To: | 3 |

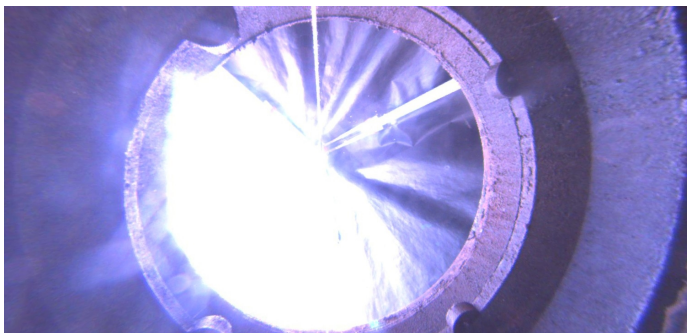
| Description: | General Observation |
| Distance (ft): | 1.5 |
| Remarks: | UNDERSIDE OF FRAME |

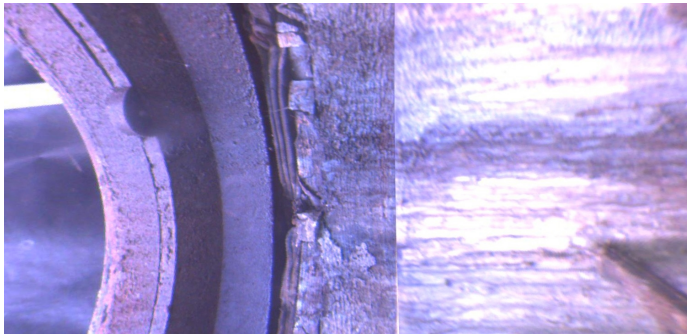
Code: **ISSR**
Description: **Intruding Sealing Ring**

Distance (ft): **1.5**
Structural Grade: **0**
O&M Grade: **2**
Clock Start/From: **9**
Clock To: **10**
1st Value:
2nd Value:
Value Percent: **0.000**
Step: **NO**
Remarks:

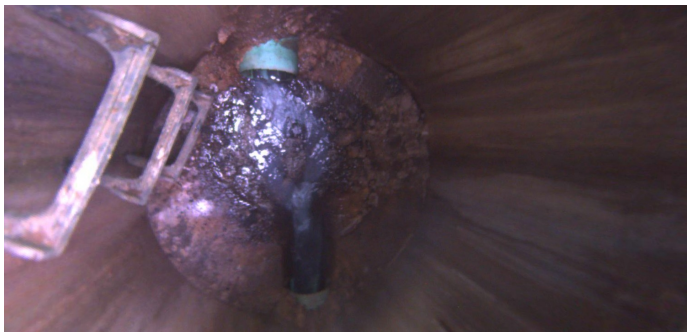
Code: **IS**
Description: **Infil Stain**

Distance (ft): **2.1**
Structural Grade: **0**
O&M Grade: **0**
Clock Start/From: **12**
Clock To: **12**
1st Value:
2nd Value:
Value Percent:
Step: **NO**
Remarks:

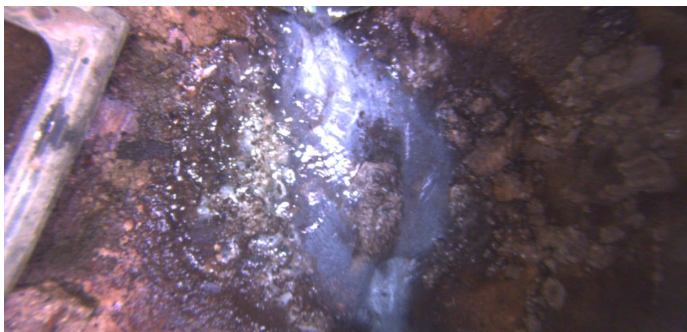
Code: **DSGV**
Description: **Deposits Settled Gravel**

Distance (ft): **4.7**
Structural Grade: **0**
O&M Grade: **2**
Clock Start/From: **12**
Clock To: **12**
1st Value:
2nd Value:
Value Percent: **10.000**
Step: **NO**
Remarks:

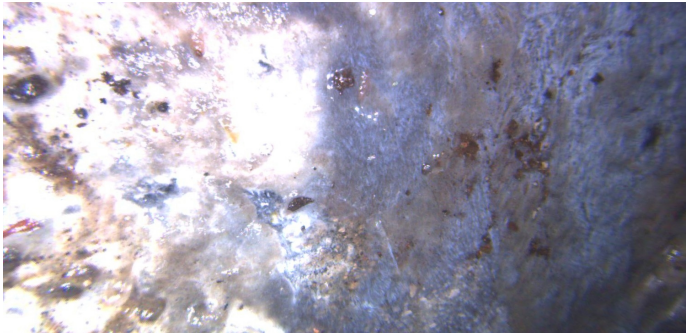
| Description: | General Observation |
| Distance (ft): | 6.2 |
| Remarks: | END SURVEY |
