Manhole Inspection Report

Date:	04/18/2018	Weather:		Coding:	RZMACP
MH#:	M-807-008	Owner:	NA	Len. Surveyed:	8.4
P.O.#:		Surveyor:	Jen Costello	Rim to Invert:	8.7
Customer:		Cert. #:	U-907-5518	Wall Material:	Concrete (reinforced)

Street:	14th St. 74' East of Linda St.	Project:	Hobart, IN
City:	Hobart, IN	GPS Northing:	2907402.421
Location:		GPS Easting:	2907402.421
Drain Area:	Southeast	GPS Accuracy:	Sub-Meter
Cover Shape:	Circular	Evidence of Surcharge:	No
Cover Size:	22.5	Potential for Runoff:	None
Comments:

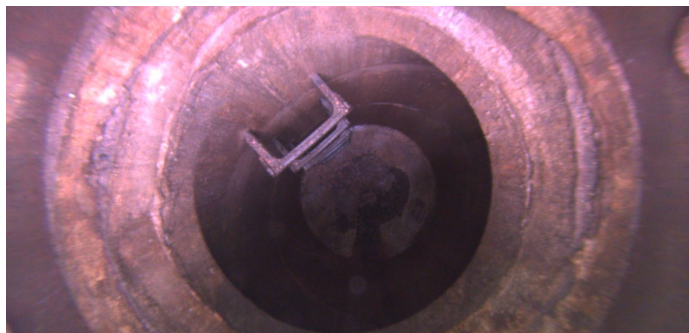
Code: **MGO**
Description: **General Observation**

Distance (ft): **.0**
Structural Grade: **0**
O&M Grade: **0**
Clock Start/From:
Clock To:
1st Value:
2nd Value:
Value Percent:
Step: **NO**
Remarks: **ACCESS MH**

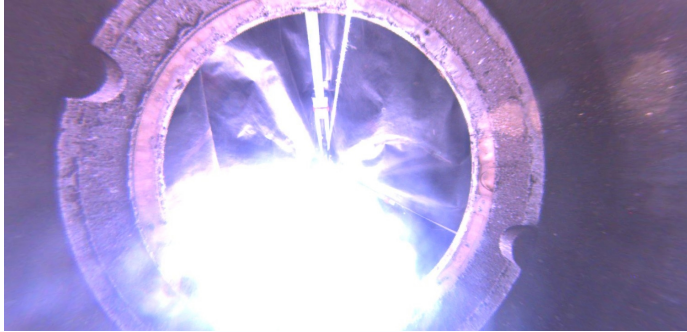
Code:	MGO
Description:	General Observation
Distance (ft):	1.5
Structural Grade:	0
O&M Grade:	0
Clock Start/From:	
Clock To:	
1st Value:	
2nd Value:	
Value Percent:	
Step:	NO
Remarks:	UNDERSIDE OF FRAME

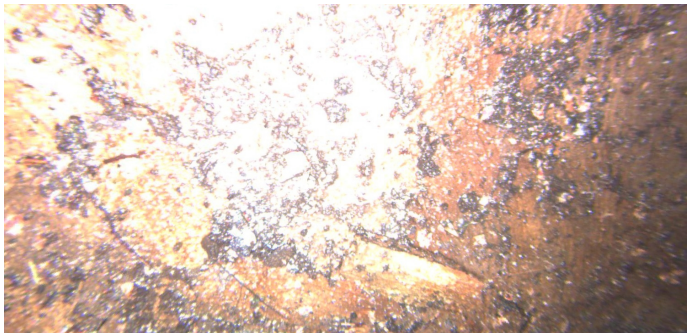
Code:	MGO
Description:	General Observation
Distance (ft):	8.4
Structural Grade:	0
O&M Grade:	0
Clock Start/From:	
Clock To:	
1st Value:	
2nd Value:	
Value Percent:	
Step:	NO
Remarks:	END SURVEY
