Manhole Inspection Report

Street:	On Hobart Rd. 79' South of 10th St.	Project:	Hobart, IN
City:	Hobart, IN	GPS Northing:	0.0
Location:		GPS Easting:	0.0
Drain Area:	Southeast	GPS Accuracy:	Nearest Meter
Cover Shape:	Circular	Evidence of Surcharge:	No
Cover Size:	22.5	Potential for Runoff:	None
Comments:

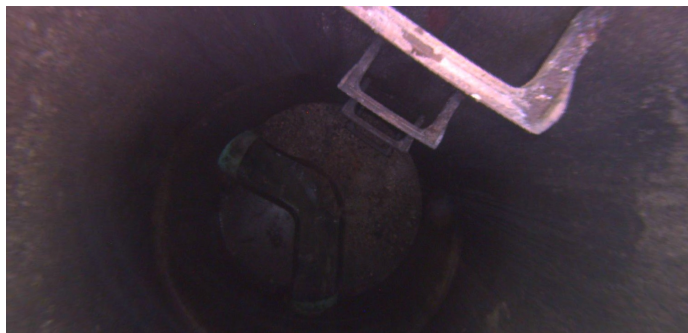
Code: **MGO**
Description: **General Observation**

Distance (ft): **.0**
Structural Grade: **0**
O&M Grade: **0**
Clock Start/From:
Clock To:
1st Value:
2nd Value:
Value Percent:
Step: **NO**
Remarks: **ACCESS MH**

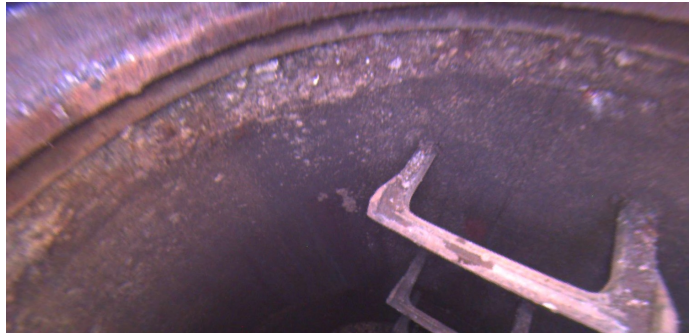
Code:	SSS
Description:	Surface Spalling
Distance (ft):	.0
Structural Grade:	2
O&M Grade:	0
Clock Start/From:	9
Clock To:	12
1st Value:	
2nd Value:	
Value Percent:	
Step:	NO
Remarks:

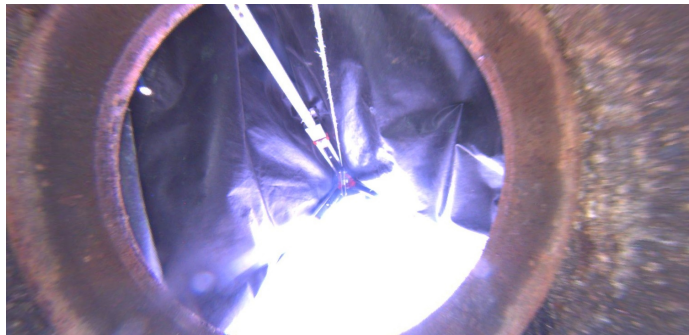
Code:	MGP
Description:	General Photo
Distance (ft):	1.3
Structural Grade:	0
O&M Grade:	0
Clock Start/From:	
Clock To:	
1st Value:	
2nd Value:	
Value Percent:	
Step:	NO
Remarks:	UNDERSIDE OF FRAME

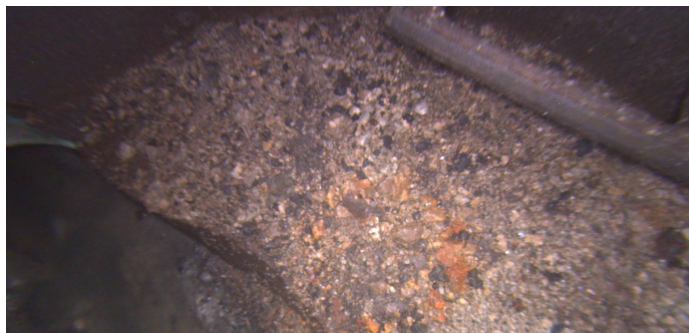
Code:	SAP
Description:	Surface Aggregate Projecting
Distance (ft):	4.8
Structural Grade:	3
O&M Grade:	0
Clock Start/From:	12
Clock To:	12
1st Value:	
2nd Value:	
Value Percent:	
Step:	NO
Remarks:

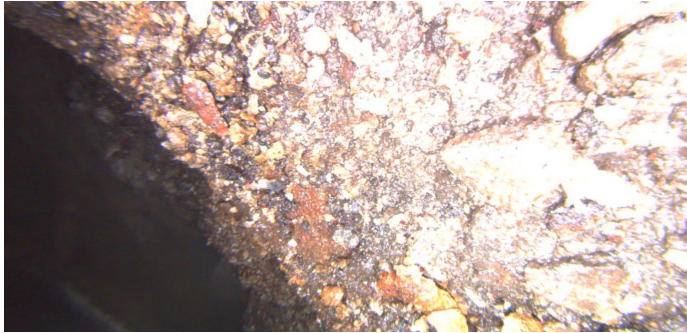
Code:	MGO
Description:	General Observation
Distance (ft):	5.8
Structural Grade:	0
O&M Grade:	0
Clock Start/From:	
Clock To:	
1st Value:	
2nd Value:	
Value Percent:	
Step:	NO
Remarks:	END SURVEY
