Manhole Inspection Report

Date:	04/21/2018	Weather:		Coding:	RZMACP
MH#:	M-807-010	Owner:	NA	Len. Surveyed:	6.8
P.O.#:		Surveyor:	Jen Costello	Rim to Invert:	7.1
Customer:	8.7	Cert. #:	U-907-5518	Wall Material:	Concrete (reinforced)

Street:	36' South of 10th St. 51' East of Hob	Project:	Hobart, IN
City:	Hobart, IN	GPS Northing:	0.0
Location:		GPS Easting:	0.0
Drain Area:	Southeast	GPS Accuracy:	Nearest Meter
Cover Shape:	Circular	Evidence of Surcharge:	No
Cover Size:	22.5	Potential for Runoff:	None
Comments:

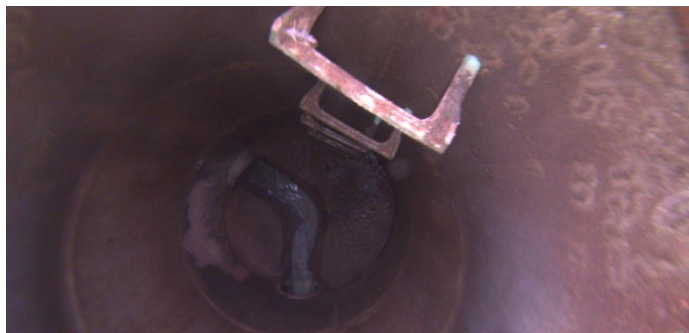
Code: **MGO**
Description: **General Observation**

Distance (ft): **.0**
Structural Grade: **0**
O&M Grade: **0**
Clock Start/From:
Clock To:
1st Value:
2nd Value:
Value Percent:
Step: **NO**
Remarks: **ACCESS MH**

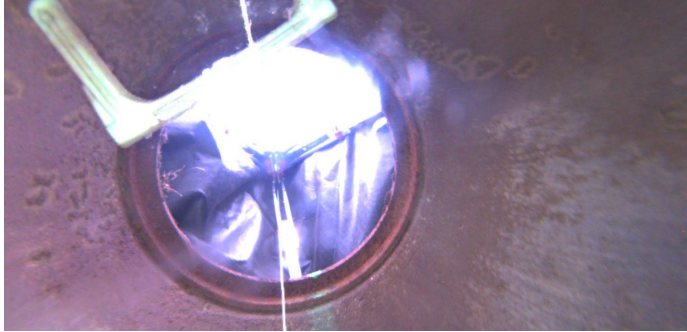
Code:	MGO
Description:	General Observation
Distance (ft):	3.1
Structural Grade:	0
O&M Grade:	0
Clock Start/From:	
Clock To:	
1st Value:	
2nd Value:	
Value Percent:	
Step:	NO
Remarks:	UNDERSIDE OF FRAME

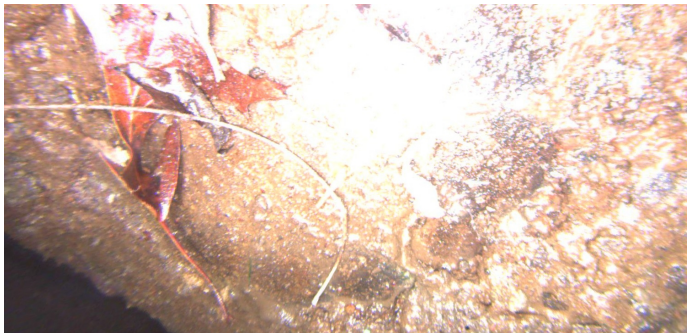
Code:	MGO
Description:	General Observation
Distance (ft):	6.8
Structural Grade:	0
O&M Grade:	0
Clock Start/From:	
Clock To:	
1st Value:	
2nd Value:	
Value Percent:	
Step:	NO
Remarks:	END SURVEY
