Manhole Inspection Report

Date:	04/22/2018	Weather:		Coding:	RZMACP
MH#:	M-807-012	Owner:	NA	Len. Surveyed:	10.9
P.O.#:		Surveyor:	Jen Costello	Rim to Invert:	11.5
Customer:	8.7	Cert. #:	U-907-5518	Wall Material:	Polyvinyl Chloride

Street:	On Hobart Rd. 284' South of 10th St.	Project:	Hobart, IN
City:	Hobart, IN	GPS Northing:	0.0
Location:		GPS Easting:	0.0
Drain Area:	Southeast	GPS Accuracy:	Nearest Meter
Cover Shape:	Circular	Evidence of Surcharge:	No
Cover Size:	22.5	Potential for Runoff:	None
Comments:

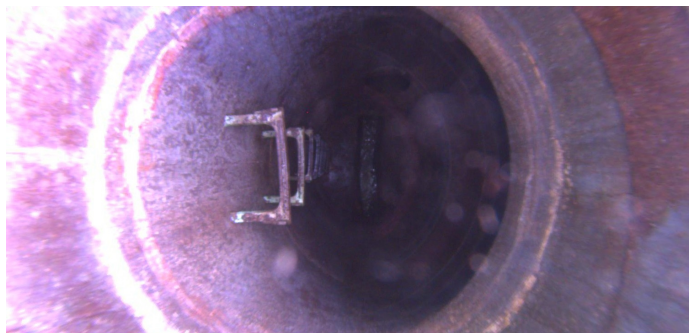
Code: **MGO**
Description: **General Observation**

Distance (ft): **.0**
Structural Grade: **0**
O&M Grade: **0**
Clock Start/From:
Clock To:
1st Value:
2nd Value:
Value Percent:
Step: **NO**
Remarks: **access MH**

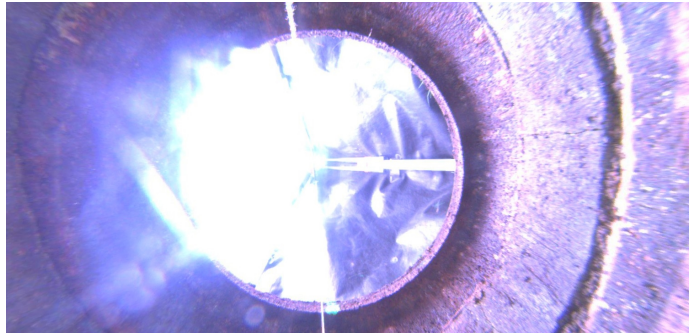
Code:	MGP
Description:	General Photo
Distance (ft):	2.0
Structural Grade:	0
O&M Grade:	0
Clock Start/From:	
Clock To:	
1st Value:	
2nd Value:	
Value Percent:	
Step:	NO
Remarks:	UNDERSIDE OF FRAME

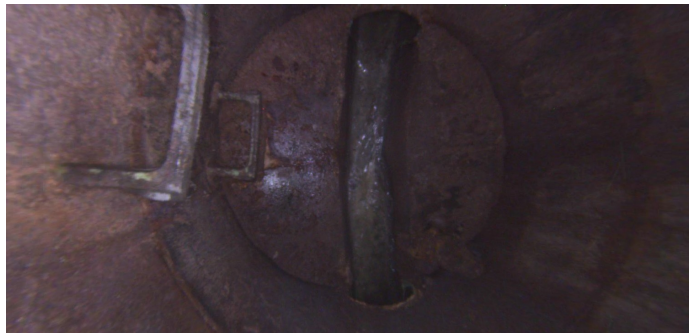
Code:	IW
Description:	Infil Weeper
Distance (ft):	7.5
Structural Grade:	0
O&M Grade:	2
Clock Start/From:	12
Clock To:	12
1st Value:	
2nd Value:	
Value Percent:	
Step:	NO
Remarks:

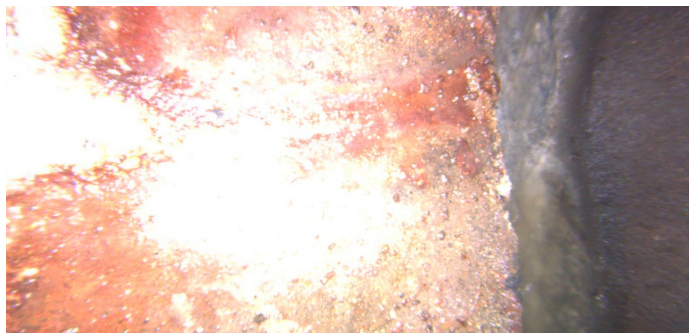
Code:	MGO
Description:	General Observation
Distance (ft):	10.9
Structural Grade:	0
O&M Grade:	0
Clock Start/From:	
Clock To:	
1st Value:	
2nd Value:	
Value Percent:	
Step:	NO
Remarks:	END SURVEY
