Manhole Inspection Report

Date:	04/18/2018	Weather:		Coding:	RZMACP
MH#:	M-807-013	Owner:	NA	Len. Surveyed:	2.3
P.O.#:		Surveyor:	Jen Costello	Rim to Invert:	3.0
Customer:		Cert. #:	U-907-5518	Wall Material:	Concrete (reinforced)

Street:	On 14th St. 328' East of Illinois St.	Project:	Hobart, IN
City:	Hobart, IN	GPS Northing:	0.0
Location:		GPS Easting:	0.0
Drain Area:	Southeast	GPS Accuracy:	Nearest Meter
Cover Shape:	Circular	Evidence of Surcharge:	No
Cover Size:	22.5	Potential for Runoff:	None
Comments:

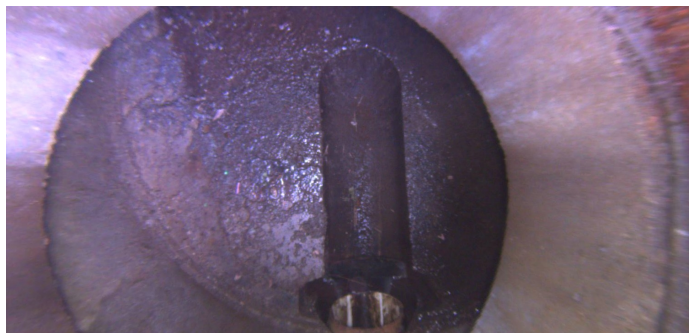
Code: **MGO**
Description: **General Observation**

Distance (ft): **.0**
Structural Grade: **0**
O&M Grade: **0**
Clock Start/From:
Clock To:
1st Value:
2nd Value:
Value Percent:
Step: **NO**
Remarks: **ACCESS MH**

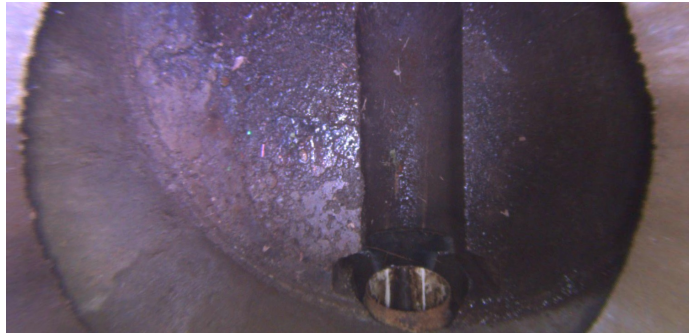
Code: **FL**
Description: **Fracture Longitudinal**

Distance (ft): **.5**
Structural Grade: **3**
O&M Grade: **0**
Clock Start/From: **8**
Clock To:
1st Value:
2nd Value:
Value Percent:
Step: **NO**
Remarks:

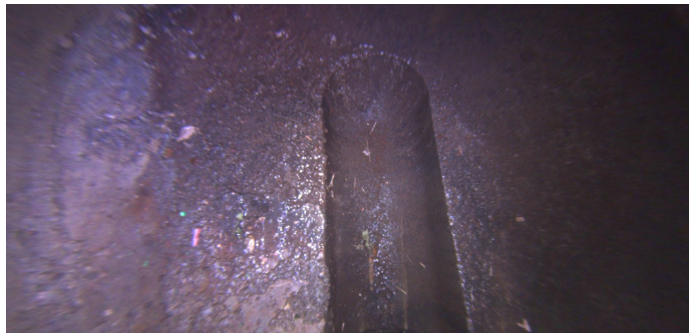
Code: **DSF**
Description: **Deposits Settled Fine**

Distance (ft): **1.3**
Structural Grade: **0**
O&M Grade: **2**
Clock Start/From: **6**
Clock To: **12**
1st Value:
2nd Value:
Value Percent: **5.000**
Step: **NO**
Remarks:

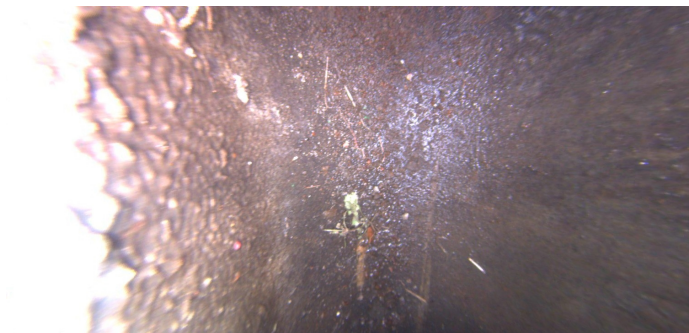
Code: **MGO**
Description: **General Observation**

Distance (ft): **2.3**
Structural Grade: **0**
O&M Grade: **0**
Clock Start/From:
Clock To:
1st Value:
2nd Value:
Value Percent:
Step: **NO**
Remarks: **end survey**
