Manhole Inspection Report

Date:	04/09/2018	Weather:		Coding:	RZMACP
MH#:	M-808-006	Owner:	NA	Len. Surveyed:	10.0
P.O.#:		Surveyor:	John Kuglmaier	Rim to Invert:	10.8
Customer:		Cert. #:	U-1215-07002349	Wall Material:	Concrete (reinforced)

Street:	Capitol Dr. 172' North of Union Ct.	Project:	Hobart, IN
City:	Hobart, IN	GPS Northing:	2908169.169
Location:		GPS Easting:	2908169.169
Drain Area:	Southwest	GPS Accuracy:	Sub-Meter
Cover Shape:	Circular	Evidence of Surcharge:	No
Cover Size:	23.0	Potential for Runoff:	None
Comments:

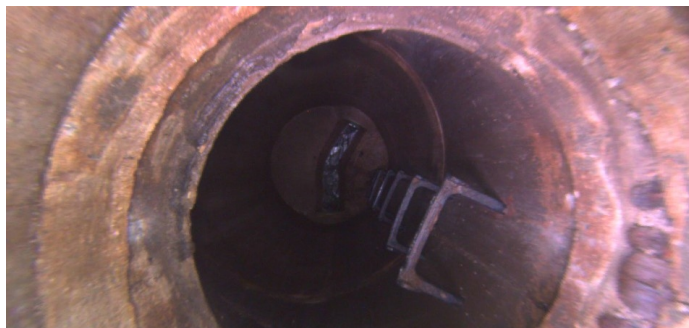
Code: **MGP**
Description: **General Photo**

Distance (ft): **.0**
Structural Grade: **0**
O&M Grade: **0**
Clock Start/From:
Clock To:
1st Value:
2nd Value:
Value Percent:
Step: **NO**
Remarks:

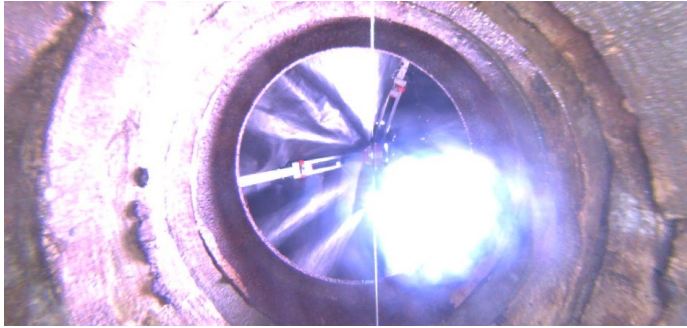
Code: **MGP**
Description: **General Photo**

Distance (ft): **2.7**
Structural Grade: **0**
O&M Grade: **0**
Clock Start/From:
Clock To:
1st Value:
2nd Value:
Value Percent:
Step: **NO**
Remarks:

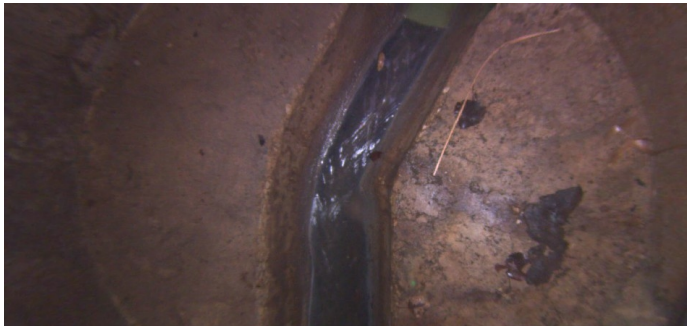
Code: **MGO**
Description: **General Observation**

Distance (ft): **8.3**
Structural Grade: **0**
O&M Grade: **0**
Clock Start/From:
Clock To:
1st Value:
2nd Value:
Value Percent:
Step: **NO**
Remarks: **Ins. Comp.**
