Manhole Inspection Report

Date:	04/09/2018	Weather:		Coding:	RZMACP
MH#:	M-808-009	Owner:	NA	Len. Surveyed:	8.4
P.O.#:		Surveyor:	John Kuglmaier	Rim to Invert:	9.3
Customer:		Cert. #:	U-1215-07002349	Wall Material:	Concrete (reinforced)

Street:	Capitol Dr. 564' West of Liberty St.	Project:	Hobart, IN
City:	Hobart, IN	GPS Northing:	2908756.457
Location:		GPS Easting:	2908756.457
Drain Area:	Southwest	GPS Accuracy:	Sub-Meter
Cover Shape:	Circular	Evidence of Surcharge:	Yes
Cover Size:	23.0	Potential for Runoff:	None
Comments:

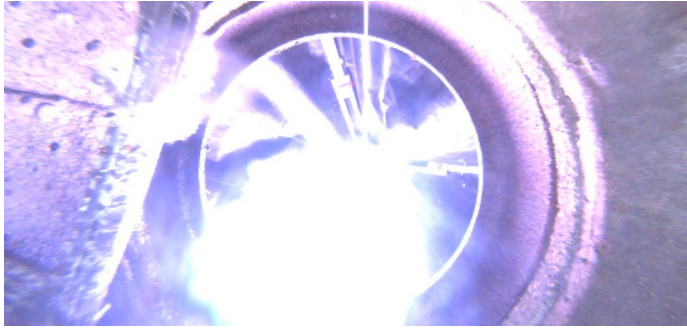
Code: **MGP**
Description: **General Photo**

Distance (ft): **2.2**
Structural Grade: **0**
O&M Grade: **0**
Clock Start/From:
Clock To:
1st Value:
2nd Value:
Value Percent:
Step: **NO**
Remarks:

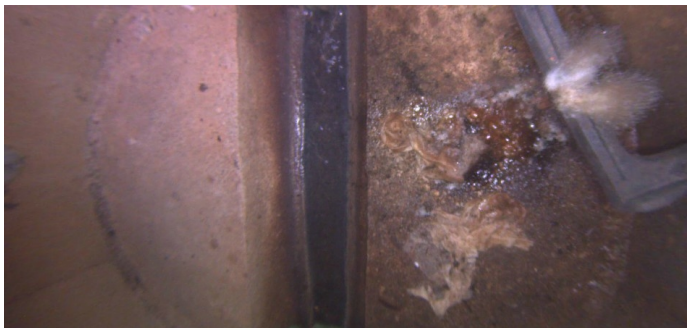
Code: **MGO**
Description: **General Observation**

Distance (ft): **7.0**
Structural Grade: **0**
O&M Grade: **0**
Clock Start/From:
Clock To:
1st Value:
2nd Value:
Value Percent:
Step: **NO**
Remarks: **Ins. Comp.**
