Manhole Inspection Report

Date:	04/09/2018	Weather:		Coding:	RZMACP
MH#:	M-808-010	Owner:	NA	Len. Surveyed:	9.5
P.O.#:		Surveyor:	John Kuglmaier	Rim to Invert:	10.1
Customer:		Cert. #:	U-1215-07002349	Wall Material:	Concrete (reinforced)

Street:	Capitol Dr. 300' North of Independe	Project:	Hobart, IN
City:	Hobart, IN	GPS Northing:	2908979.423
Location:		GPS Easting:	2908979.423
Drain Area:	Southwest	GPS Accuracy:	Sub-Meter
Cover Shape:	Circular	Evidence of Surcharge:	No
Cover Size:	23.0	Potential for Runoff:	None
Comments:

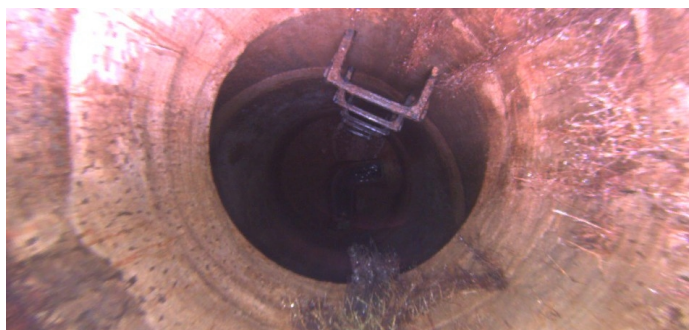
Code: **MGP**
Description: **General Photo**

Distance (ft): **.0**
Structural Grade: **0**
O&M Grade: **0**
Clock Start/From:
Clock To:
1st Value:
2nd Value:
Value Percent:
Step: **NO**
Remarks:

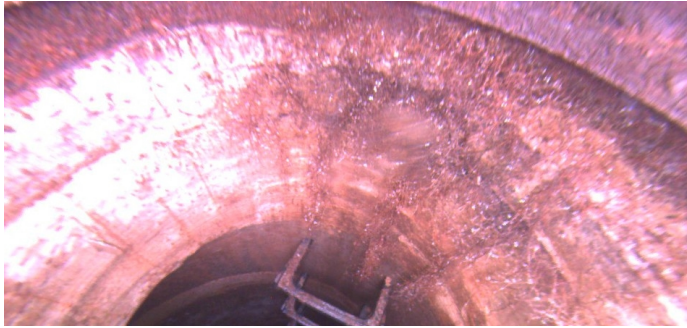
Code:	RFJ
Description:	Roots Fine Joint
Distance (ft):	.0
Structural Grade:	0
O&M Grade:	1
Clock Start/From:	12
Clock To:	7
1st Value:	
2nd Value:	
Value Percent:	
Step:	NO
Remarks:

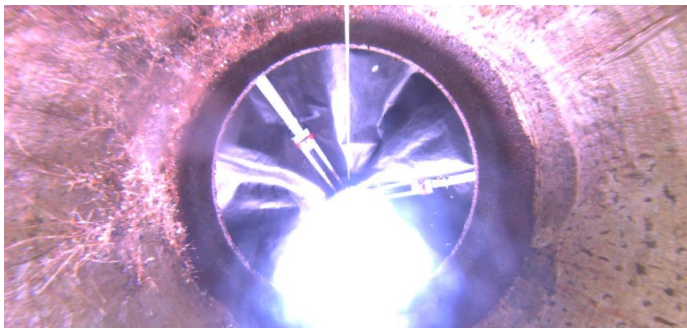
Code:	MGP
Description:	General Photo
Distance (ft):	2.5
Structural Grade:	0
O&M Grade:	0
Clock Start/From:	
Clock To:	
1st Value:	
2nd Value:	
Value Percent:	
Step:	NO
Remarks:

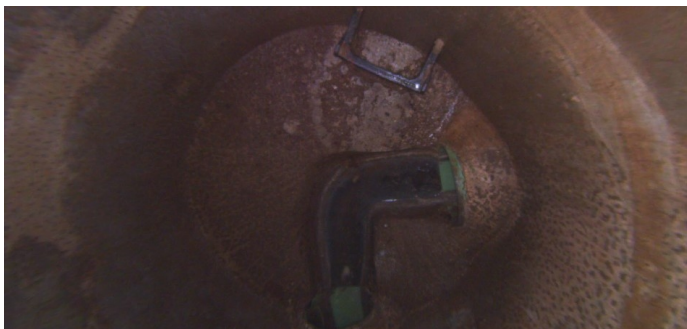
Code:	DSF
Description:	Deposits Settled Fine
Distance (ft):	6.2
Structural Grade:	0
O&M Grade:	2
Clock Start/From:	12
Clock To:	12
1st Value:	
2nd Value:	
Value Percent:	5.000
Step:	NO
Remarks:

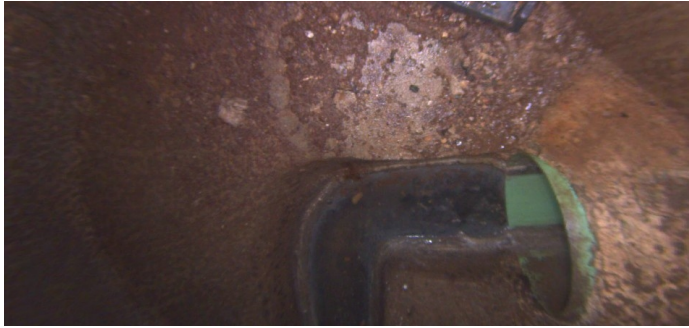
Code:	MGO
Description:	General Observation
Distance (ft):	8.1
Structural Grade:	0
O&M Grade:	0
Clock Start/From:	
Clock To:	
1st Value:	
2nd Value:	
Value Percent:	
Step:	NO
Remarks:	Ins. Comp.
