Manhole Inspection Report

Date:	04/09/2018	Weather:		Coding:	RZMACP
MH#:	M-808-013	Owner:	NA	Len. Surveyed:	9.8
P.O.#:		Surveyor:	John Kuglmaier	Rim to Invert:	10.6
Customer:		Cert. #:	U-1215-07002349	Wall Material:	Concrete (reinforced)

Street:	Independence Dr. 227' East of Capit	Project:	Hobart, IN
City:	Hobart, IN	GPS Northing:	2909213.29
Location:		GPS Easting:	2909213.29
Drain Area:	Southwest	GPS Accuracy:	Sub-Meter
Cover Shape:	Circular	Evidence of Surcharge:	No
Cover Size:	23.0	Potential for Runoff:	None
Comments:

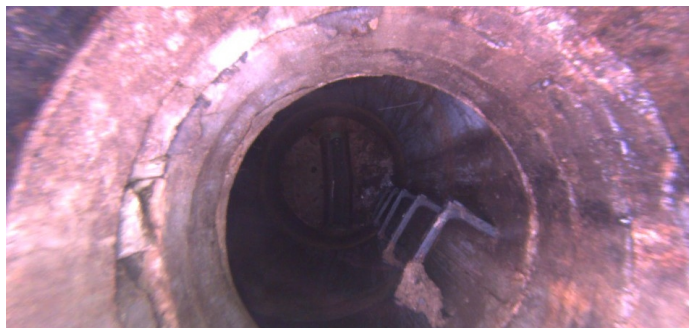
Code: **MGP**
Description: **General Photo**

Distance (ft): **.0**
Structural Grade: **0**
O&M Grade: **0**
Clock Start/From:
Clock To:
1st Value:
2nd Value:
Value Percent:
Step: **NO**
Remarks:

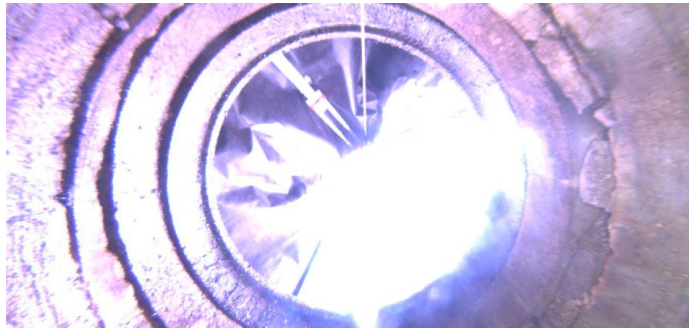
Code: **MGP**
Description: **General Photo**

Distance (ft): **2.5**
Structural Grade: **0**
O&M Grade: **0**
Clock Start/From:
Clock To:
1st Value:
2nd Value:
Value Percent:
Step: **NO**
Remarks:

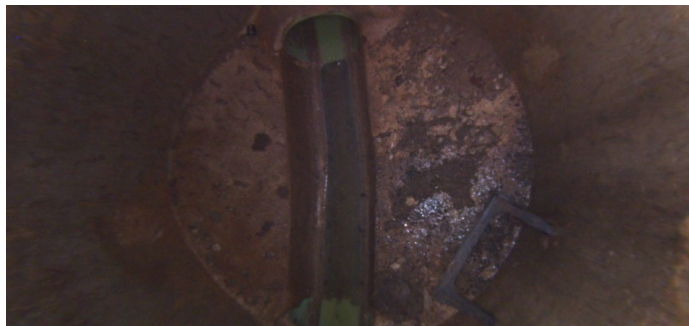
Code: **DSF**
Description: **Deposits Settled Fine**

Distance (ft): **7.1**
Structural Grade: **0**
O&M Grade: **2**
Clock Start/From: **12**
Clock To: **6**
1st Value:
2nd Value:
Value Percent: **5.000**
Step: **NO**
Remarks:

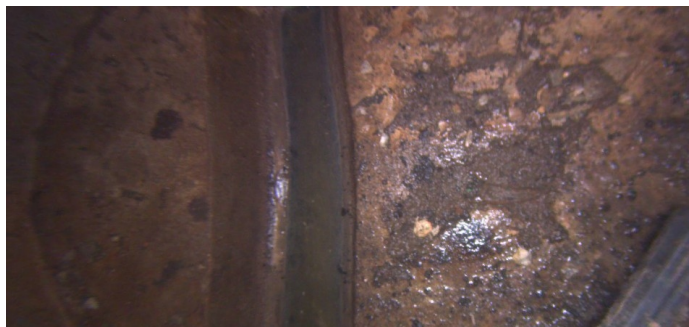
Code: **MGO**
Description: **General Observation**

Distance (ft): **8.7**
Structural Grade: **0**
O&M Grade: **0**
Clock Start/From:
Clock To:
1st Value:
2nd Value:
Value Percent:
Step: **NO**
Remarks: **Ins. Comp.**
