Manhole Inspection Report

Date:	04/09/2018	Weather:		Coding:	RZMACP
MH#:	M-808-016	Owner:	NA	Len. Surveyed:	5.0
P.O.#:		Surveyor:	John Kuglmaier	Rim to Invert:	5.6
Customer:		Cert. #:	U-1215-07002349	Wall Material:	Concrete (reinforced)

Street:	Liberty St. 421' South of Independen	Project:	Hobart, IN
City:	Hobart, IN	GPS Northing:	2909598.571
Location:		GPS Easting:	2909598.571
Drain Area:	Southwest	GPS Accuracy:	Sub-Meter
Cover Shape:	Circular	Evidence of Surcharge:	No
Cover Size:	23.5	Potential for Runoff:	None
Comments:

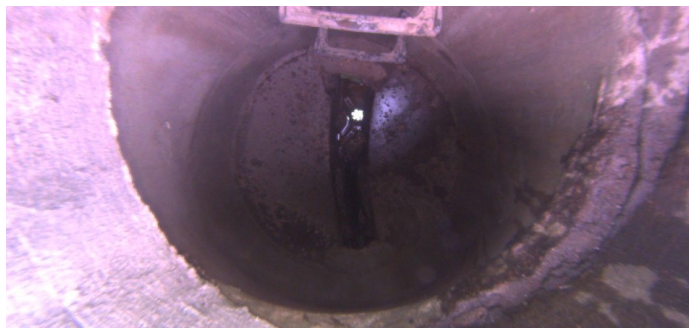
Code: **MGP**
Description: **General Photo**

Distance (ft): **.0**
Structural Grade: **0**
O&M Grade: **0**
Clock Start/From:
Clock To:
1st Value:
2nd Value:
Value Percent:
Step: **NO**
Remarks:

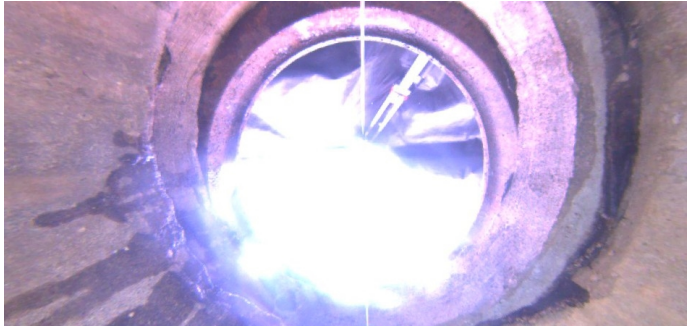
Code: **MGP**
Description: **General Photo**

Distance (ft): **2.5**
Structural Grade: **0**
O&M Grade: **0**
Clock Start/From:
Clock To:
1st Value:
2nd Value:
Value Percent:
Step: **NO**
Remarks:

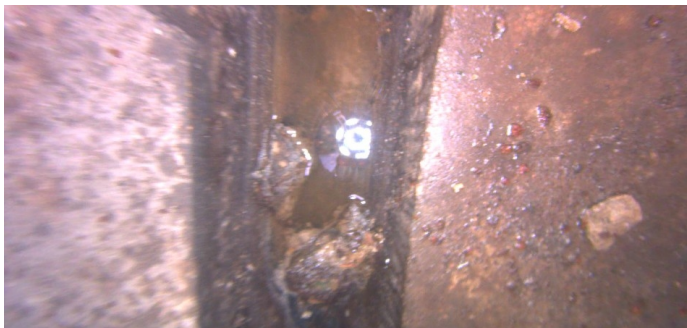
Code: **MGO**
Description: **General Observation**

Distance (ft): **4.4**
Structural Grade: **0**
O&M Grade: **0**
Clock Start/From:
Clock To:
1st Value:
2nd Value:
Value Percent:
Step: **NO**
Remarks: **Ins. Comp.**
