Manhole Inspection Report

Date:	04/09/2018	Weather:		Coding:	RZMACP
MH#:	M-808-019	Owner:	NA	Len. Surveyed:	4.8
P.O.#:		Surveyor:	John Kuglmaier	Rim to Invert:	5.4
Customer:		Cert. #:	U-1215-07002349	Wall Material:	Concrete (reinforced)

Street:	Liberty St. 204' North of Independen	Project:	Hobart, IN
City:	Hobart, IN	GPS Northing:	2909294.445
Location:		GPS Easting:	2909294.445
Drain Area:	Southwest	GPS Accuracy:	Sub-Meter
Cover Shape:	Circular	Evidence of Surcharge:	No
Cover Size:	23.0	Potential for Runoff:	None
Comments:

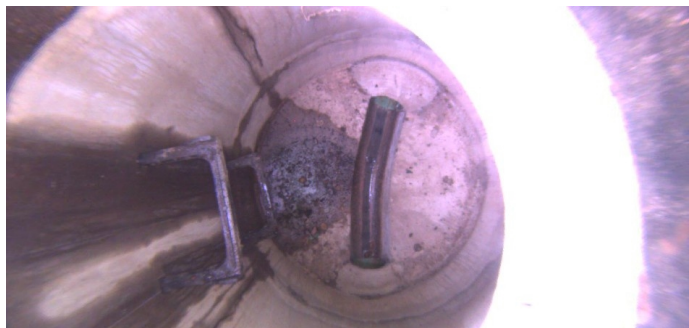
Code: **MGP**
Description: **General Photo**

Distance (ft): **.0**
Structural Grade: **0**
O&M Grade: **0**
Clock Start/From:
Clock To:
1st Value:
2nd Value:
Value Percent:
Step: **NO**
Remarks:

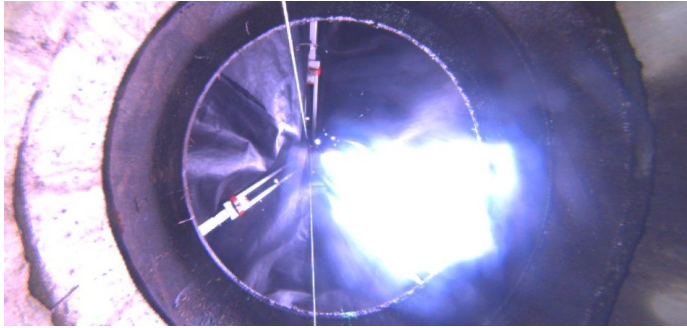
Code: **MGP**
Description: **General Photo**

Distance (ft): **2.2**
Structural Grade: **0**
O&M Grade: **0**
Clock Start/From:
Clock To:
1st Value:
2nd Value:
Value Percent:
Step: **NO**
Remarks:

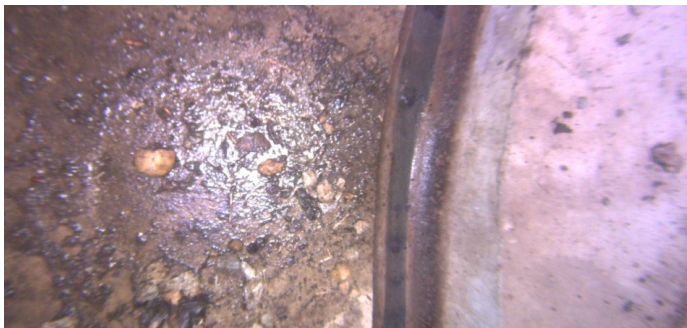
Code: **MGO**
Description: **General Observation**

Distance (ft): **4.0**
Structural Grade: **0**
O&M Grade: **0**
Clock Start/From:
Clock To:
1st Value:
2nd Value:
Value Percent:
Step: **NO**
Remarks: **Ins. Comp.**
