# Manhole Inspection Report

Date:	<b>04/09/2018</b>	Weather:		Coding:	<b>RZMACP</b>
MH#:	<b>M-808-021</b>	Owner:	<b>NA</b>	Len. Surveyed:	<b>4.5</b>
P.O.#:		Surveyor:	<b>John Kuglmaier</b>	Rim to Invert:	<b>5.2</b>
Customer:		Cert. #:	<b>U-1215-07002349</b>	Wall Material:	<b>Concrete (reinforced)</b>

Street:	<b>Independence Dr. 351' West of Capi</b>	Project:	<b>Hobart, IN</b>
City:	<b>Hobart, IN</b>	GPS Northing:	<b>2908635.838</b>
Location:		GPS Easting:	<b>2908635.838</b>
Drain Area:	<b>Southwest</b>	GPS Accuracy:	<b>Sub-Meter</b>
Cover Shape:	<b>Circular</b>	Evidence of Surcharge:	<b>No</b>
Cover Size:	<b>23.0</b>	Potential for Runoff:	<b>None</b>
Comments:

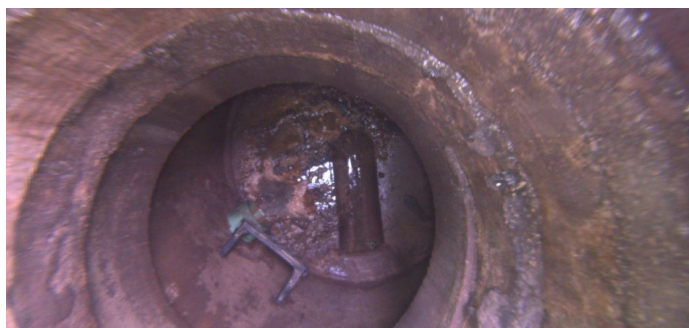
Code: **MGP**  
Description: **General Photo**

Distance (ft): **.0**  
Structural Grade: **0**  
O&M Grade: **0**  
Clock Start/From:  
Clock To:  
1st Value:  
2nd Value:  
Value Percent:  
Step: **NO**  
Remarks:

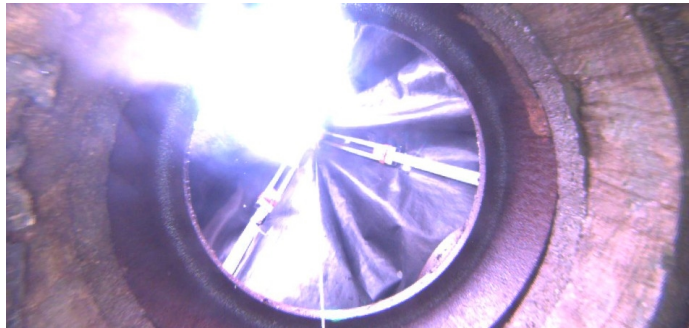
Code: **MGP**  
Description: **General Photo**

Distance (ft): **2.1**  
Structural Grade: **0**  
O&M Grade: **0**  
Clock Start/From:  
Clock To:  
1st Value:  
2nd Value:  
Value Percent:  
Step: **NO**  
Remarks:

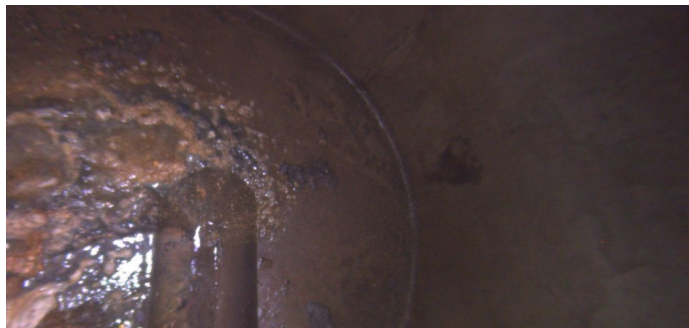
Code: **IS**  
Description: **Infil Stain**

Distance (ft): **2.2**  
Structural Grade: **0**  
O&M Grade: **0**  
Clock Start/From: **2**  
Clock To:  
1st Value:  
2nd Value:  
Value Percent:  
Step: **NO**  
Remarks:

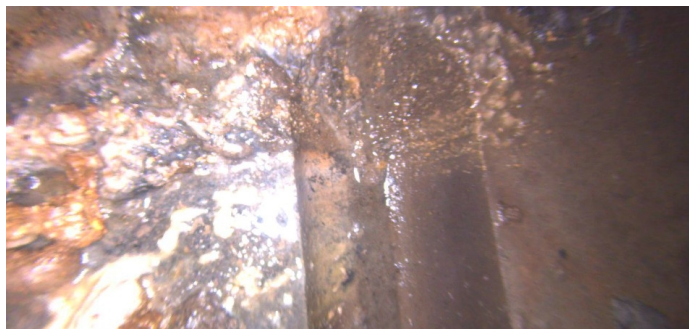
Code: **MGO**  
Description: **General Observation**

Distance (ft): **3.8**  
Structural Grade: **0**  
O&M Grade: **0**  
Clock Start/From:  
Clock To:  
1st Value:  
2nd Value:  
Value Percent:  
Step: **NO**  
Remarks: **Ins. Comp.**
