Manhole Inspection Report

Date:	11/02/2022	Weather:		Coding:	RZMACP
MH#:	M-808-022	Owner:	NA	Len. Surveyed:	7.2
P.O.#:		Surveyor:	Jen Costello	Rim to Invert:	8.1
Customer:		Cert. #:	U-907-5518	Wall Material:	Concrete (non-reinforced)

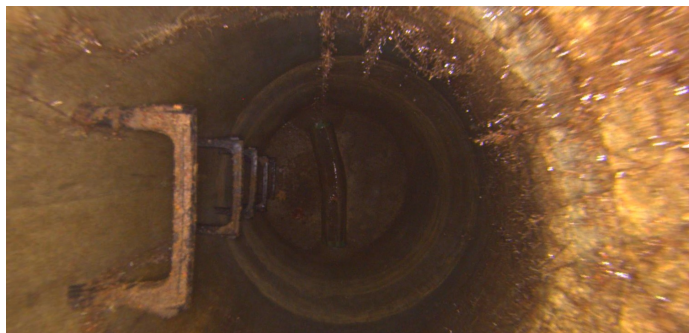
Code: **RFJ**
Description: **Roots Fine Joint**

Distance (ft): **.0**
Structural Grade: **0**
O&M Grade: **1**
Clock Start/From: **12**
Clock To: **12**
1st Value:
2nd Value:
Value Percent:
Step: **NO**
Remarks:

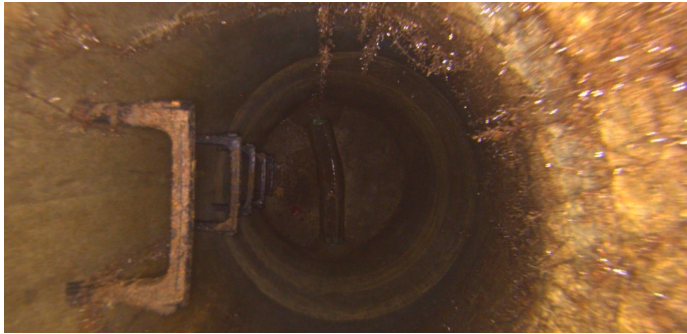
Code: **SRI**
Description: **Surface Roughness Increased**

Distance (ft): **.0**
Structural Grade: **1**
O&M Grade: **0**
Clock Start/From: **12**
Clock To: **12**
1st Value:
2nd Value:
Value Percent:
Step: **NO**
Remarks:

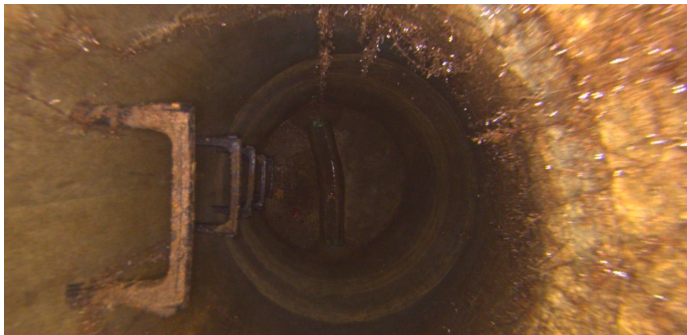
Code: **MGO**
Description: **General Observation**

Distance (ft): **.0**
Structural Grade: **0**
O&M Grade: **0**
Clock Start/From:
Clock To:
1st Value:
2nd Value:
Value Percent:
Step: **NO**
Remarks: **access mh**

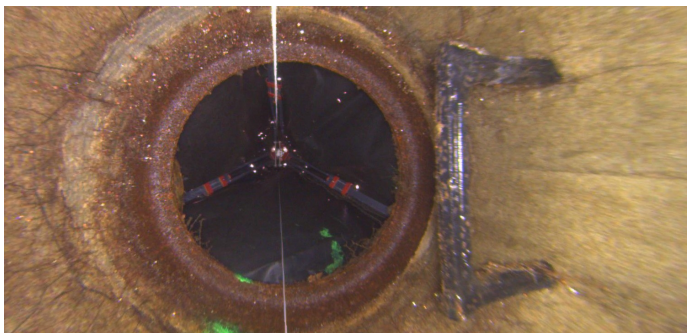
Code: **MGO**
Description: **General Observation**

Distance (ft): **2.4**
Structural Grade: **0**
O&M Grade: **0**
Clock Start/From:
Clock To:
1st Value:
2nd Value:
Value Percent:
Step: **NO**
Remarks: **underside of frame**

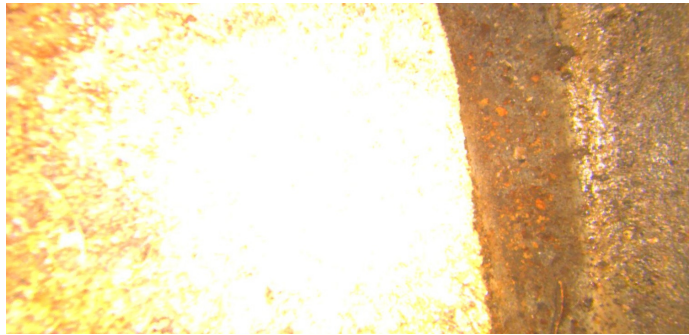
Code: **MGO**
Description: **General Observation**

Distance (ft): **7.2**
Structural Grade: **0**
O&M Grade: **0**
Clock Start/From:
Clock To:
1st Value:
2nd Value:
Value Percent:
Step: **NO**
Remarks: **end of survey**

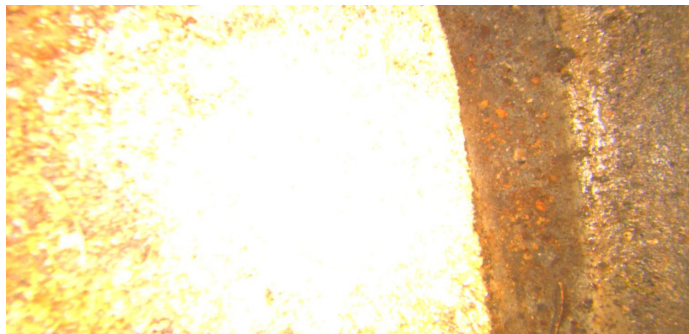
Code: **SRI**
Description: **Surface Roughness Increased**

Distance (ft): **7.2**
Structural Grade: **1**
O&M Grade: **0**
Clock Start/From: **12**
Clock To: **12**
1st Value:
2nd Value:
Value Percent:
Step: **NO**
Remarks:

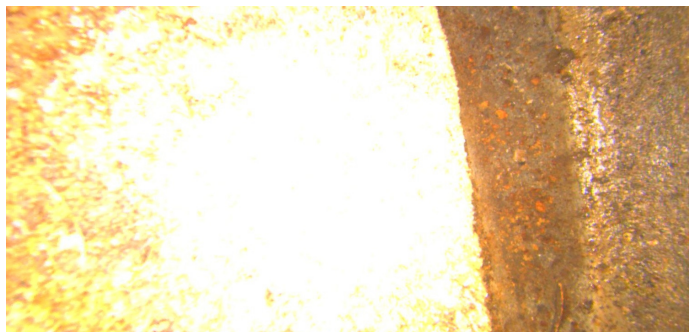
Code: **DSF**
Description: **Deposits Settled Fine**

Distance (ft): **7.2**
Structural Grade: **0**
O&M Grade: **2**
Clock Start/From: **12**
Clock To: **12**
1st Value:
2nd Value:
Value Percent: **5.000**
Step: **NO**
Remarks:

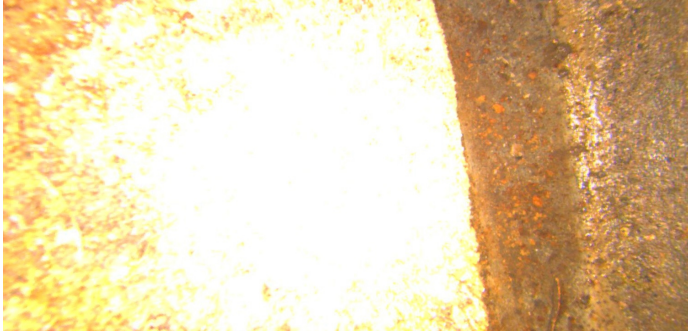
Code:	SAV
Description:	Surface Aggregate Visible
Distance (ft):	7.2
Structural Grade:	3
O&M Grade:	0
Clock Start/From:	3
Clock To:	9
1st Value:	
2nd Value:	
Value Percent:	
Step:	NO
Remarks:
