Manhole Inspection Report

| MH#: | M-808-023 | Owner: | NA | Len. Surveyed: | 7.8 |

| Street: | Union Ct. 255' Northwest of Capital | Project: | Hobart, IN |

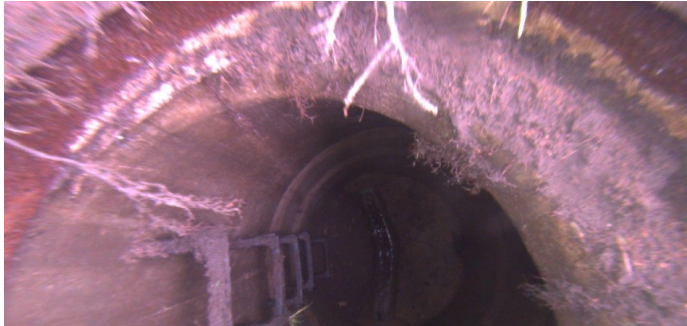
| Position | Code | Observation | Video (sec) | Grade |
|---|---|---|---|---|
| .0 | MGP | General Photo | 10 | NA |

| Code: | MGP |
| Description: | General Photo |

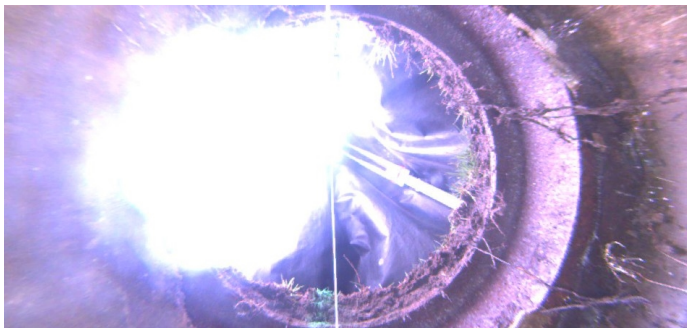
| Position | Code | Observation | Video (sec) | Grade |
|---|---|---|---|---|
| .0 | RFJ | Roots Fine Joint | 22 | M 1 |

| Code: | RFJ |
| Description: | Roots Fine Joint |
| Distance (ft): | .0 |
| O&M Grade: | 1 |
| Clock Start/From: | 11 |
| Clock To: | 8 |

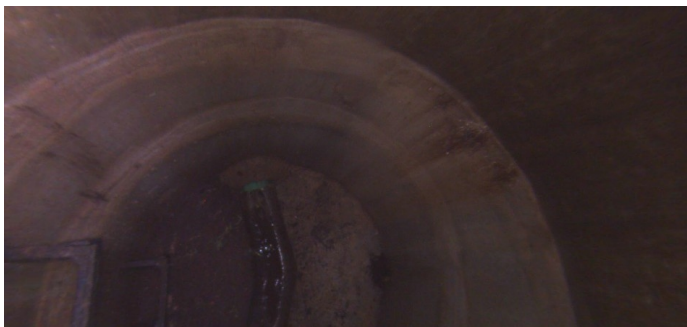
| Position | Code | Observation | Video (sec) | Grade |
|---|---|---|---|---|
| 2.3 | MGP | General Photo | 40 | NA |

| Code: | MGP |
| Description: | General Photo |
| Distance (ft): | 2.3 |

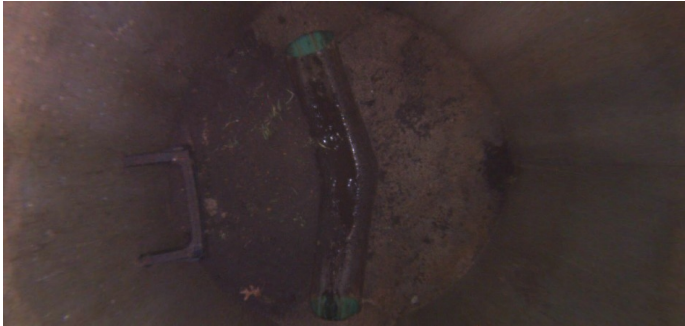
| Position | Code | Observation | Video (sec) | Grade |
|---|---|---|---|---|
| 4.7 | DSF | Deposits Settled Fine | 70 | M 2 |

| Code: | DSF |
| Description: | Deposits Settled Fine |

| Distance (ft): | 4.7 |
| O&M Grade: | 2 |
| Clock Start/From: | 6 |
| Clock To: | 11 |
| Value Percent: | 5.000 |

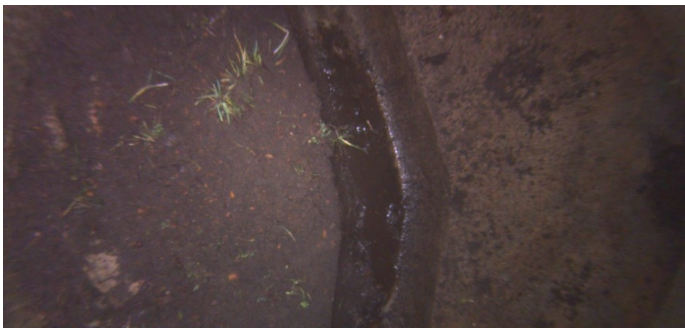
| Position | Code | Observation | Video (sec) | Grade |
|---|---|---|---|---|
| 6.5 | MGO | General Observation | 85 | NA |

| Code: | MGO |
| Description: | General Observation |

| Distance (ft): | 6.5 |
| Remarks: | Ins. Comp. |
