Manhole Inspection Report

Date:	04/09/2018	Weather:		Coding:	RZMACP
MH#:	M-808-024	Owner:	NA	Len. Surveyed:	4.2
P.O.#:		Surveyor:	John Kuglmaier	Rim to Invert:	4.9
Customer:		Cert. #:	U-1215-07002349	Wall Material:	Concrete (reinforced)

Street:	Union Ct. at Cul De Sac.	Project:	Hobart, IN
City:	Hobart, IN	GPS Northing:	2907485.002
Location:		GPS Easting:	2907485.002
Drain Area:	Southwest	GPS Accuracy:	Sub-Meter
Cover Shape:	Circular	Evidence of Surcharge:	No
Cover Size:	22.0	Potential for Runoff:	None
Comments:

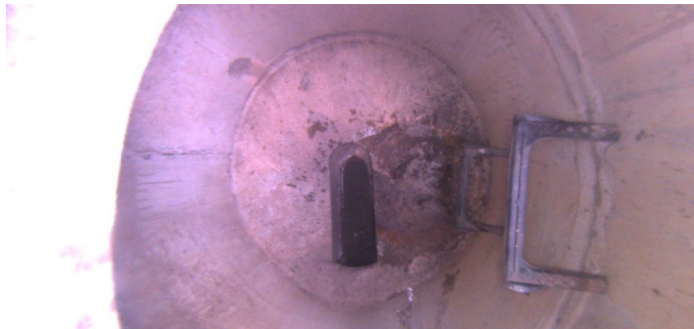
Code: **MGP**
Description: **General Photo**

Distance (ft): **.0**
Structural Grade: **0**
O&M Grade: **0**
Clock Start/From:
Clock To:
1st Value:
2nd Value:
Value Percent:
Step: **NO**
Remarks:

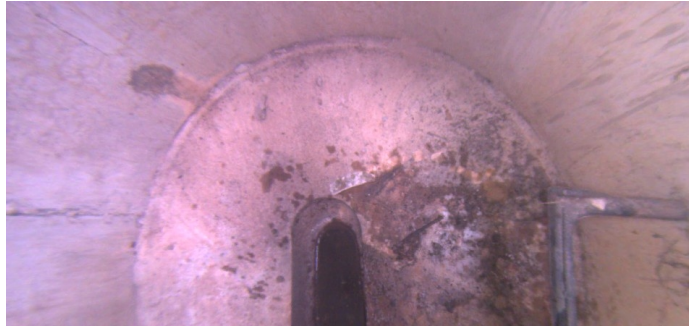
Code: **IS**
Description: **Infil Stain**

Distance (ft): **1.9**
Structural Grade: **0**
O&M Grade: **0**
Clock Start/From: **10**
Clock To:
1st Value:
2nd Value:
Value Percent:
Step: **NO**
Remarks:

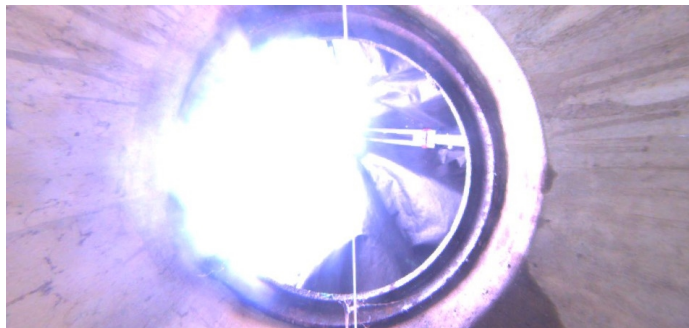
Code: **MGP**
Description: **General Photo**

Distance (ft): **2.2**
Structural Grade: **0**
O&M Grade: **0**
Clock Start/From:
Clock To:
1st Value:
2nd Value:
Value Percent:
Step: **NO**
Remarks:

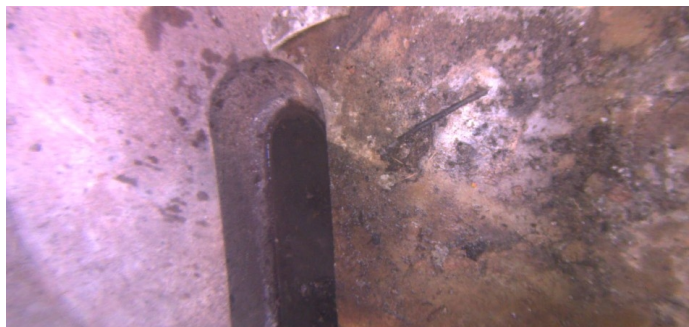
Code: **MGO**
Description: **General Observation**

Distance (ft): **3.0**
Structural Grade: **0**
O&M Grade: **0**
Clock Start/From:
Clock To:
1st Value:
2nd Value:
Value Percent:
Step: **NO**
Remarks: **Ins. Comp.**
