Manhole Inspection Report

Date:	04/11/2018	Weather:		Coding:	RZMACP
MH#:	M-808-025	Owner:	NA	Len. Surveyed:	6.3
P.O.#:		Surveyor:	John Kuglmaier	Rim to Invert:	7.3
Customer:		Cert. #:	U-1215-07002349	Wall Material:	Concrete (reinforced)

Street:	On Hobart Rd. 208' North of 61st Av	Project:	Hobart, IN
City:	Hobart, IN	GPS Northing:	2910016.28
Location:		GPS Easting:	2910016.28
Drain Area:	Southeast	GPS Accuracy:	Sub-Meter
Cover Shape:	Circular	Evidence of Surcharge:	Yes
Cover Size:	22.5	Potential for Runoff:	None
Comments:

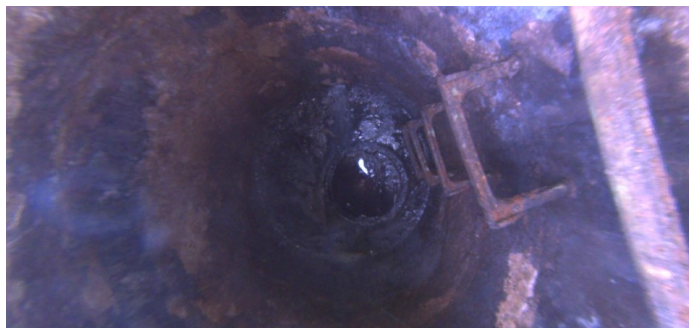
Code: **MGP**
Description: **General Photo**

Distance (ft): **.0**
Structural Grade: **0**
O&M Grade: **0**
Clock Start/From:
Clock To:
1st Value:
2nd Value:
Value Percent:
Step: **NO**
Remarks:

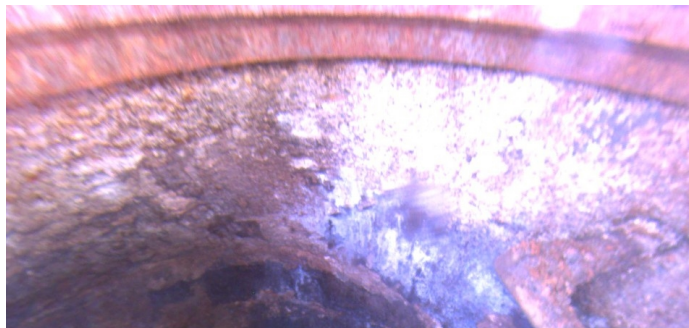
Code: **DAZ**
 Description: **Deposits Attached Other**

Distance (ft): **.0**
 Structural Grade: **0**
 O&M Grade: **2**
 Clock Start/From: **12**
 Clock To: **12**
 1st Value:
 2nd Value:
 Value Percent: **10.000**
 Step: **NO**
 Remarks: **Mixed materials**

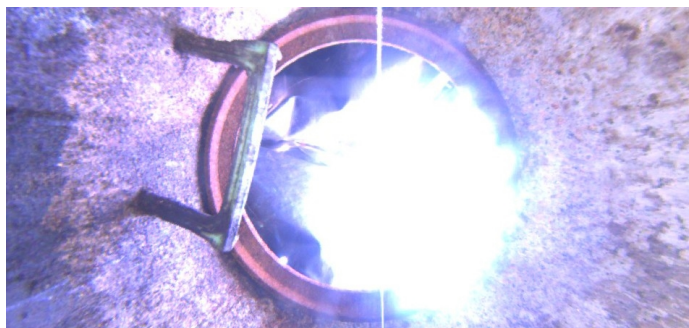
Code: **MGP**
 Description: **General Photo**

Distance (ft): **2.3**
 Structural Grade: **0**
 O&M Grade: **0**
 Clock Start/From:
 Clock To:
 1st Value:
 2nd Value:
 Value Percent:
 Step: **NO**
 Remarks:

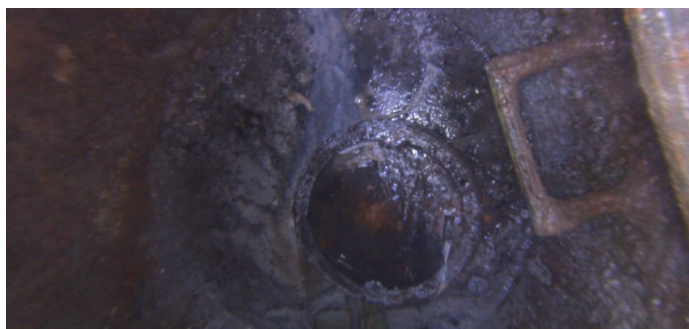
Code: **DAZ**
 Description: **Deposits Attached Other**

Distance (ft): **3.7**
 Structural Grade: **0**
 O&M Grade: **3**
 Clock Start/From: **12**
 Clock To: **12**
 1st Value:
 2nd Value:
 Value Percent: **15.000**
 Step: **NO**
 Remarks: **Mixed materials**

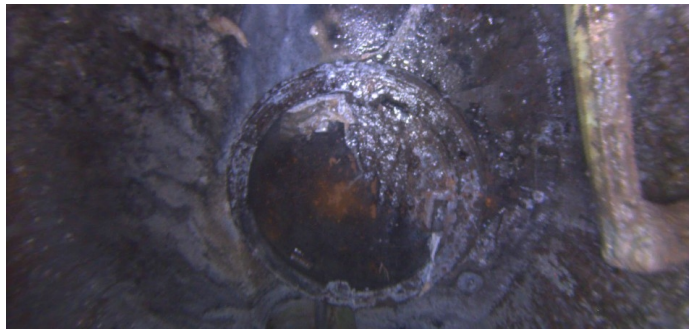
Code: **OBZ**
Description: **Obstacle Other**

Distance (ft): **4.7**
Structural Grade: **0**
O&M Grade: **2**
Clock Start/From: **3**
Clock To: **7**
1st Value:
2nd Value:
Value Percent: **5.000**
Step: **NO**
Remarks: **Ring**

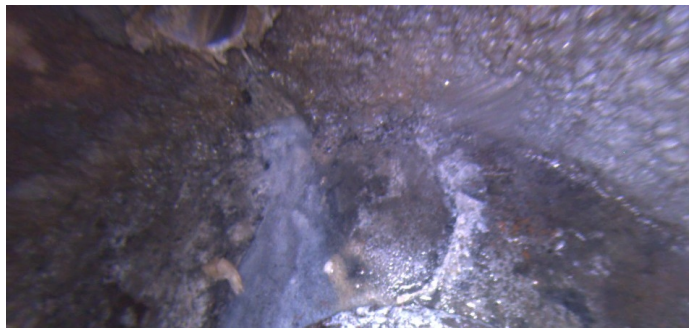
Code: **DAZ**
Description: **Deposits Attached Other**

Distance (ft): **5.3**
Structural Grade: **0**
O&M Grade: **2**
Clock Start/From: **12**
Clock To: **12**
1st Value:
2nd Value:
Value Percent: **10.000**
Step: **NO**
Remarks: **Mixed materials**

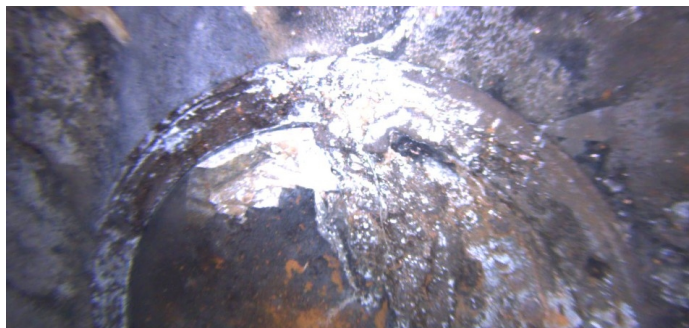
Code: **MGO**
Description: **General Observation**

Distance (ft): **5.8**
Structural Grade: **0**
O&M Grade: **0**
Clock Start/From:
Clock To:
1st Value:
2nd Value:
Value Percent:
Step: **NO**
Remarks: **Ins. Comp.**
