Manhole Inspection Report

Date:	04/13/2018	Weather:		Coding:	RZMACP
MH#:	M-809-001	Owner:	NA	Len. Surveyed:	5.9
P.O.#:		Surveyor:	John Kuglmaier	Rim to Invert:	6.7
Customer:		Cert. #:	U-1215-07002349	Wall Material:	Concrete (reinforced)

Street:	Grosbeak Ct. South End of Cul DE Sa	Project:	Hobart, IN
City:	Hobart, IN	GPS Northing:	2908875.103
Location:		GPS Easting:	2908875.103
Drain Area:	Southwest	GPS Accuracy:	Sub-Meter
Cover Shape:	Circular	Evidence of Surcharge:	No
Cover Size:	22.5	Potential for Runoff:	None
Comments:

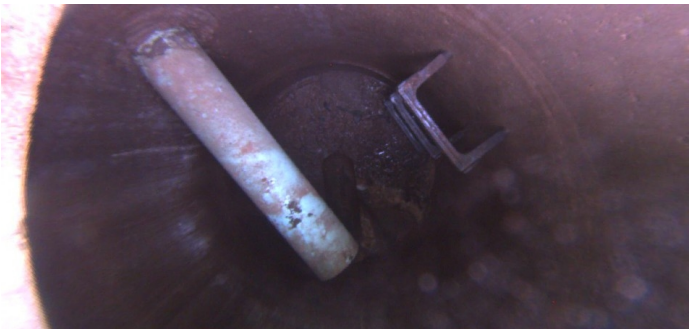
Code: **MGP**
Description: **General Photo**

Distance (ft): **.0**
Structural Grade: **0**
O&M Grade: **0**
Clock Start/From:
Clock To:
1st Value:
2nd Value:
Value Percent:
Step: **NO**
Remarks:

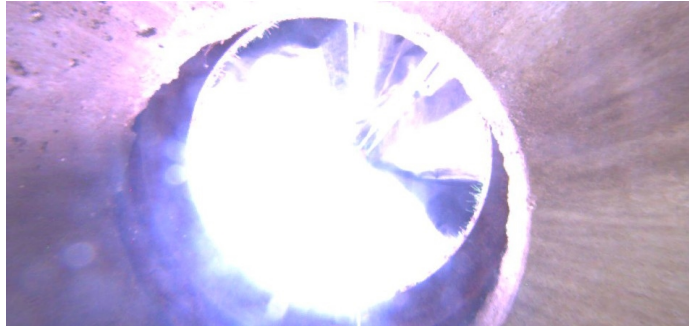
Code: **MGP**
Description: **General Photo**

Distance (ft): **2.2**
Structural Grade: **0**
O&M Grade: **0**
Clock Start/From:
Clock To:
1st Value:
2nd Value:
Value Percent:
Step: **NO**
Remarks:

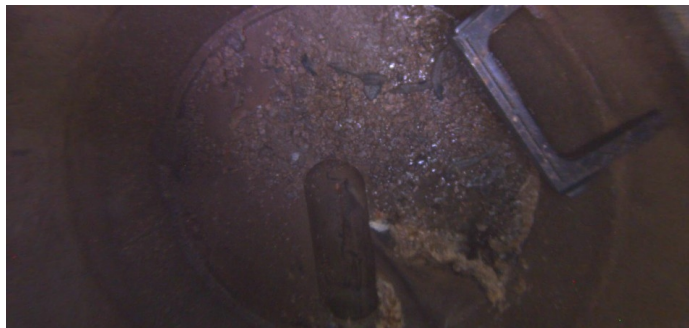
Code: **DAZ**
Description: **Deposits Attached Other**

Distance (ft): **3.2**
Structural Grade: **0**
O&M Grade: **2**
Clock Start/From: **12**
Clock To: **12**
1st Value:
2nd Value:
Value Percent: **5.000**
Step: **NO**
Remarks: **Mixed materials**

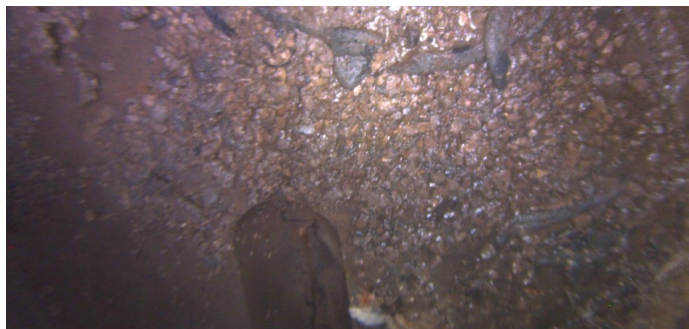
Code: **MGO**
Description: **General Observation**

Distance (ft): **4.8**
Structural Grade: **0**
O&M Grade: **0**
Clock Start/From:
Clock To:
1st Value:
2nd Value:
Value Percent:
Step: **NO**
Remarks: **Ins. Comp.**
