Manhole Inspection Report

Date:	04/13/2018	Weather:		Coding:	RZMACP
MH#:	M-809-002	Owner:	NA	Len. Surveyed:	5.9
P.O.#:		Surveyor:	John Kuglmaier	Rim to Invert:	6.9
Customer:		Cert. #:	U-1215-07002349	Wall Material:	Concrete (reinforced)

Street:	Grosbeak Ct. 367' South of Tanager	Project:	Hobart, IN
City:	Hobart, IN	GPS Northing:	2908877.576
Location:		GPS Easting:	2908877.576
Drain Area:	Southwest	GPS Accuracy:	Sub-Meter
Cover Shape:	Circular	Evidence of Surcharge:	No
Cover Size:	22.5	Potential for Runoff:	None
Comments:

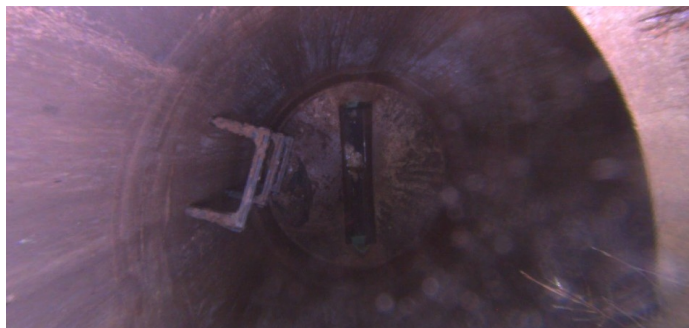
Code: **MGP**
 Description: **General Photo**

Distance (ft): **.0**
 Structural Grade: **0**
 O&M Grade: **0**
 Clock Start/From:
 Clock To:
 1st Value:
 2nd Value:
 Value Percent:
 Step: **NO**
 Remarks:

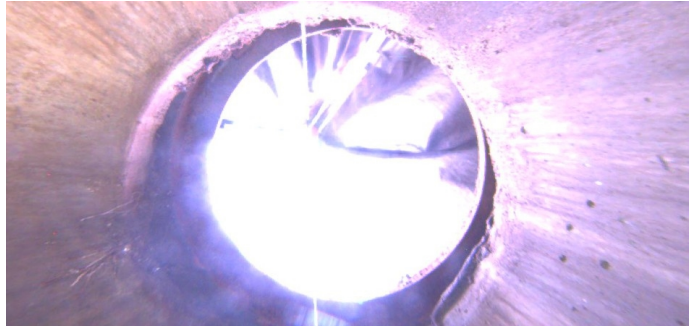
Code: **MGP**
Description: **General Photo**

Distance (ft): **2.3**
Structural Grade: **0**
O&M Grade: **0**
Clock Start/From:
Clock To:
1st Value:
2nd Value:
Value Percent:
Step: **NO**
Remarks:

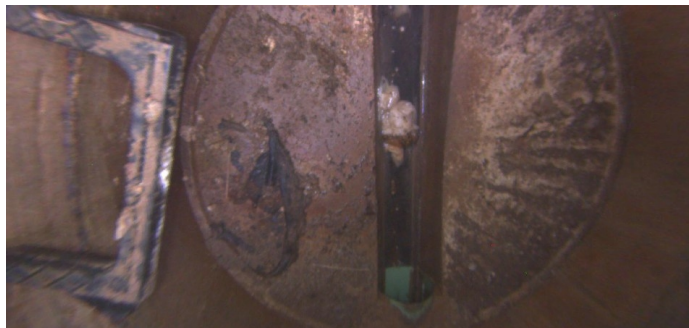
Code: **OBZ**
Description: **Obstacle Other**

Distance (ft): **3.9**
Structural Grade: **0**
O&M Grade: **2**
Clock Start/From: **7**
Clock To: **9**
1st Value:
2nd Value:
Value Percent: **5.000**
Step: **NO**
Remarks: **Plastic bag**

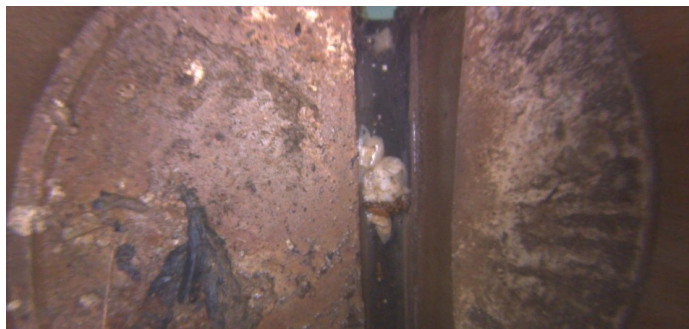
Code: **MGO**
Description: **General Observation**

Distance (ft): **4.8**
Structural Grade: **0**
O&M Grade: **0**
Clock Start/From:
Clock To:
1st Value:
2nd Value:
Value Percent:
Step: **NO**
Remarks: **Ins. Comp.**
