Manhole Inspection Report

Date:	04/13/2018	Weather:		Coding:	RZMACP
MH#:	M-809-005	Owner:	NA	Len. Surveyed:	8.0
P.O.#:		Surveyor:	John Kuglmaier	Rim to Invert:	8.5
Customer:		Cert. #:	U-1215-07002349	Wall Material:	Concrete (reinforced)

Street:	Grosbeak Ct. 118' South of Tanager	Project:	Hobart, IN
City:	Hobart, IN	GPS Northing:	2908949.017
Location:		GPS Easting:	2908949.017
Drain Area:	Southwest	GPS Accuracy:	Sub-Meter
Cover Shape:	Circular	Evidence of Surcharge:	No
Cover Size:	22.5	Potential for Runoff:	None
Comments:

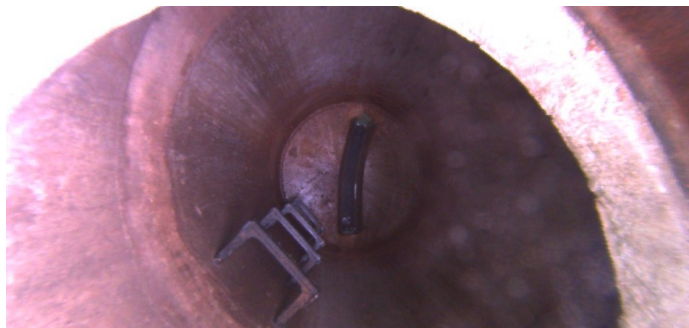
Code: **MGP**
Description: **General Photo**

Distance (ft): **.0**
Structural Grade: **0**
O&M Grade: **0**
Clock Start/From:
Clock To:
1st Value:
2nd Value:
Value Percent:
Step: **NO**
Remarks:

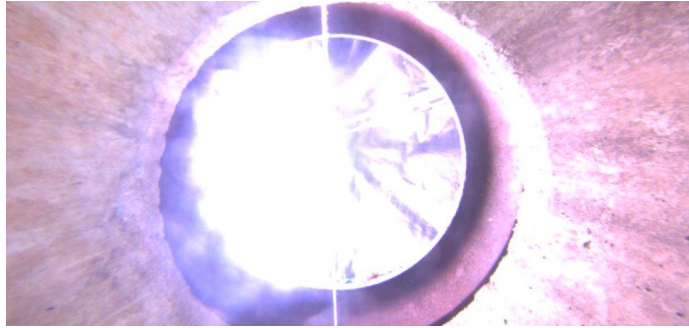
Code: **MGP**
Description: **General Photo**

Distance (ft): **2.5**
Structural Grade: **0**
O&M Grade: **0**
Clock Start/From:
Clock To:
1st Value:
2nd Value:
Value Percent:
Step: **NO**
Remarks:

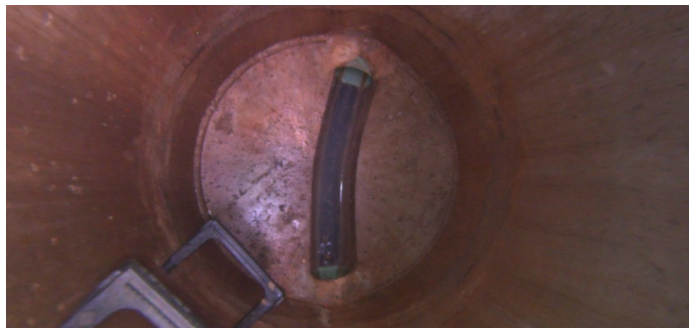
Code: **IS**
Description: **Infil Stain**

Distance (ft): **3.7**
Structural Grade: **0**
O&M Grade: **0**
Clock Start/From: **12**
Clock To: **12**
1st Value:
2nd Value:
Value Percent:
Step: **NO**
Remarks:

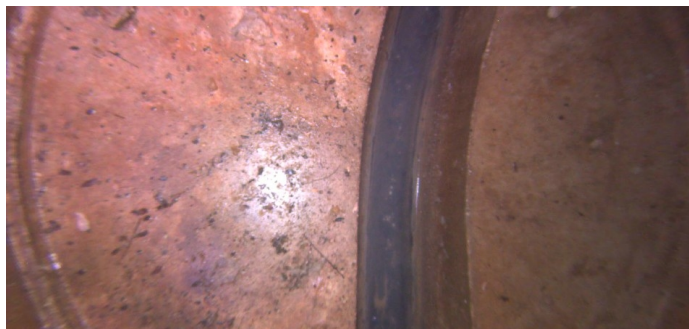
Code: **MGO**
Description: **General Observation**

Distance (ft): **6.7**
Structural Grade: **0**
O&M Grade: **0**
Clock Start/From:
Clock To:
1st Value:
2nd Value:
Value Percent:
Step: **NO**
Remarks: **Ins. Comp.**
