Manhole Inspection Report

Date:	04/13/2018	Weather:		Coding:	RZMACP
MH#:	M-809-006	Owner:	NA	Len. Surveyed:	8.5
P.O.#:		Surveyor:	John Kuglmaier	Rim to Invert:	9.1
Customer:		Cert. #:	U-1215-07002349	Wall Material:	Concrete (reinforced)

Street:	Intersection of Tanager St. and Gros	Project:	Hobart, IN
City:	Hobart, IN	GPS Northing:	2908940.759
Location:		GPS Easting:	2908940.759
Drain Area:	Southwest	GPS Accuracy:	Sub-Meter
Cover Shape:	Circular	Evidence of Surcharge:	No
Cover Size:	22.5	Potential for Runoff:	None
Comments:

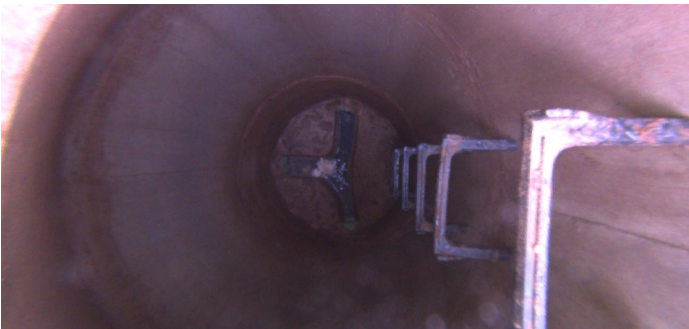
Code: **MGP**
 Description: **General Photo**

Distance (ft): **.0**
 Structural Grade: **0**
 O&M Grade: **0**
 Clock Start/From:
 Clock To:
 1st Value:
 2nd Value:
 Value Percent:
 Step: **NO**
 Remarks:

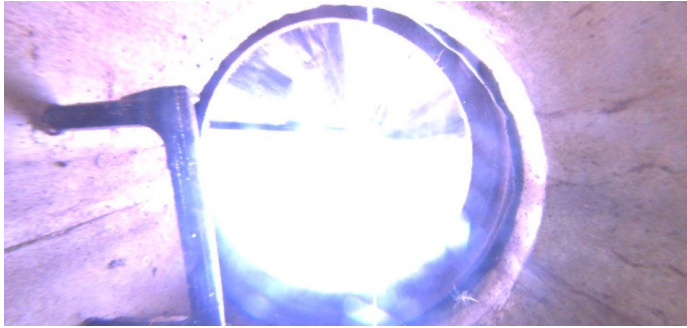
Code: **MGP**
Description: **General Photo**

Distance (ft): **2.2**
Structural Grade: **0**
O&M Grade: **0**
Clock Start/From:
Clock To:
1st Value:
2nd Value:
Value Percent:
Step: **NO**
Remarks:

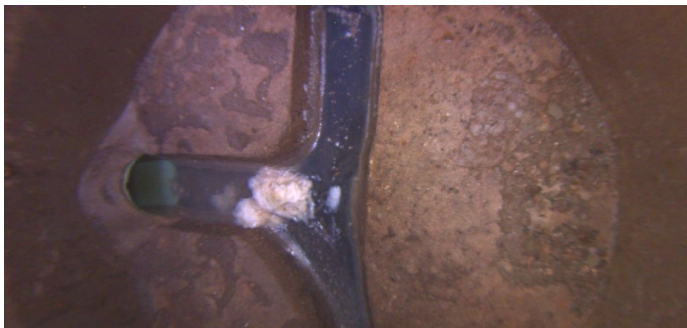
Code: **MGO**
Description: **General Observation**

Distance (ft): **6.6**
Structural Grade: **0**
O&M Grade: **0**
Clock Start/From:
Clock To:
1st Value:
2nd Value:
Value Percent:
Step: **NO**
Remarks: **Ins. Comp.**
