Manhole Inspection Report

Date:	04/13/2018	Weather:		Coding:	RZMACP
MH#:	M-809-007	Owner:	NA	Len. Surveyed:	6.2
P.O.#:		Surveyor:	John Kuglmaier	Rim to Invert:	6.7
Customer:		Cert. #:	U-1215-07002349	Wall Material:	Concrete (reinforced)

Street:	Tanager St. 335' East of Grosbeak Ct.	Project:	Hobart, IN
City:	Hobart, IN	GPS Northing:	2909245.468
Location:		GPS Easting:	2909245.468
Drain Area:	Southwest	GPS Accuracy:	Sub-Meter
Cover Shape:	Circular	Evidence of Surcharge:	No
Cover Size:	22.5	Potential for Runoff:	None
Comments:

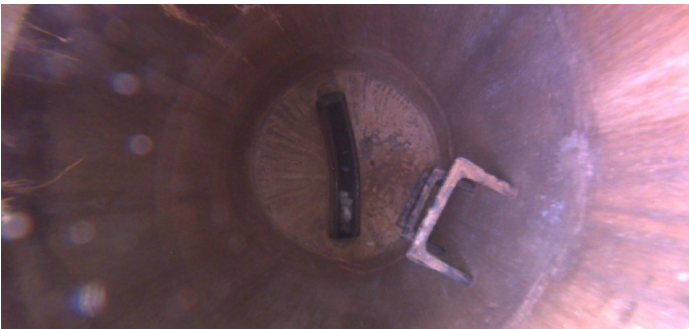
Code: **MGP**
 Description: **General Photo**

Distance (ft): **.0**
 Structural Grade: **0**
 O&M Grade: **0**
 Clock Start/From:
 Clock To:
 1st Value:
 2nd Value:
 Value Percent:
 Step: **NO**
 Remarks:

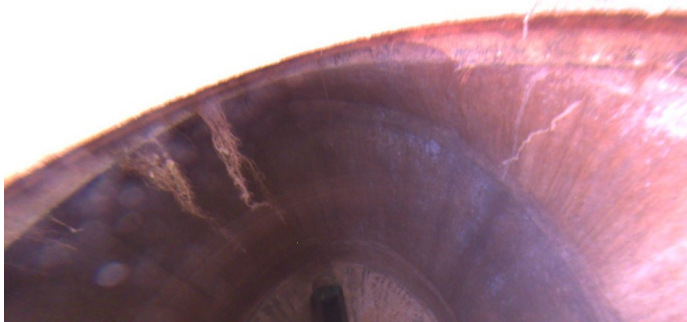
Code: **RFJ**
Description: **Roots Fine Joint**

Distance (ft): **.0**
Structural Grade: **0**
O&M Grade: **1**
Clock Start/From: **11**
Clock To:
1st Value:
2nd Value:
Value Percent:
Step: **NO**
Remarks:

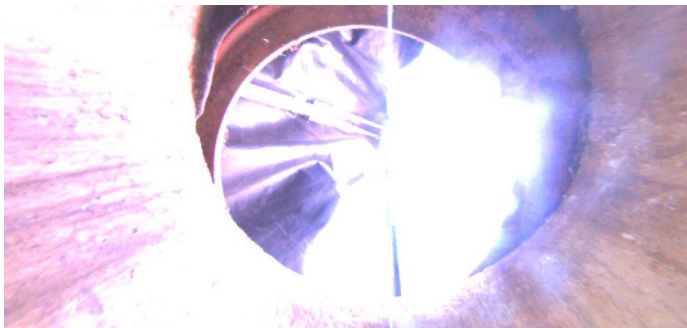
Code: **MGP**
Description: **General Photo**

Distance (ft): **2.1**
Structural Grade: **0**
O&M Grade: **0**
Clock Start/From:
Clock To:
1st Value:
2nd Value:
Value Percent:
Step: **NO**
Remarks:

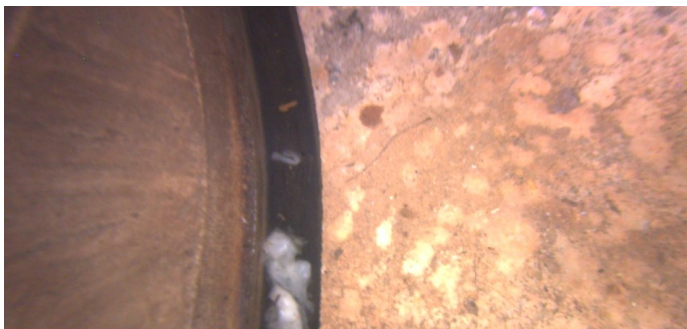
Code: **MGO**
Description: **General Observation**

Distance (ft): **5.1**
Structural Grade: **0**
O&M Grade: **0**
Clock Start/From:
Clock To:
1st Value:
2nd Value:
Value Percent:
Step: **NO**
Remarks: **Ins. Comp.**
