Manhole Inspection Report

| MH#: | M-809-009 | Owner: | NA | Len. Surveyed: | 8.8 |

| Street: | Grosbeak Ct. 171' North of Tanager | Project: | Hobart, IN |

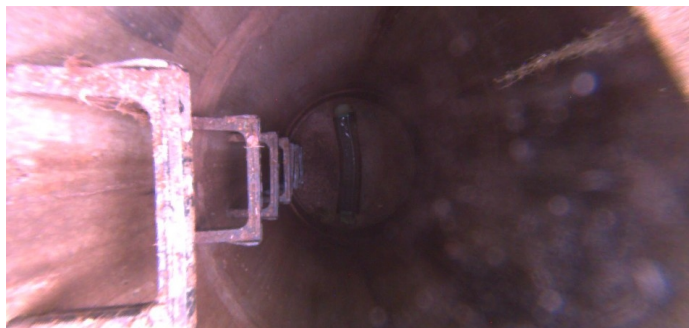
Code: **MGP**
Description: **General Photo**

Distance (ft): **.0**
Structural Grade: **0**
O&M Grade: **0**
Clock Start/From:
Clock To:
1st Value:
2nd Value:
Value Percent:
Step: **NO**
Remarks:

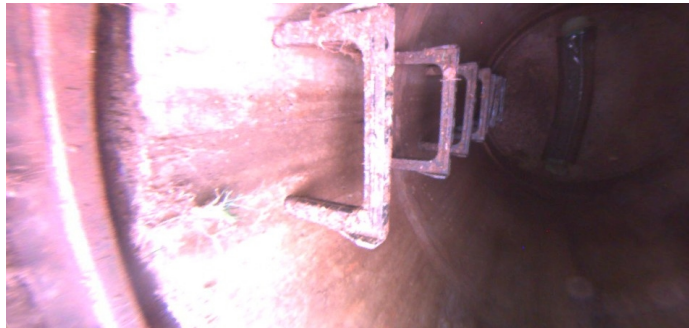
Code: **RFJ**
Description: **Roots Fine Joint**

Distance (ft): **.0**
Structural Grade: **0**
O&M Grade: **1**
Clock Start/From: **8**
Clock To:
1st Value:
2nd Value:
Value Percent:
Step: **NO**
Remarks:

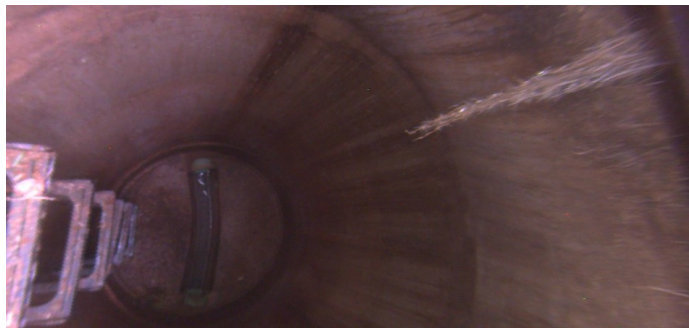
Code: **RFJ**
Description: **Roots Fine Joint**

Distance (ft): **.3**
Structural Grade: **0**
O&M Grade: **1**
Clock Start/From: **2**
Clock To:
1st Value:
2nd Value:
Value Percent:
Step: **NO**
Remarks:

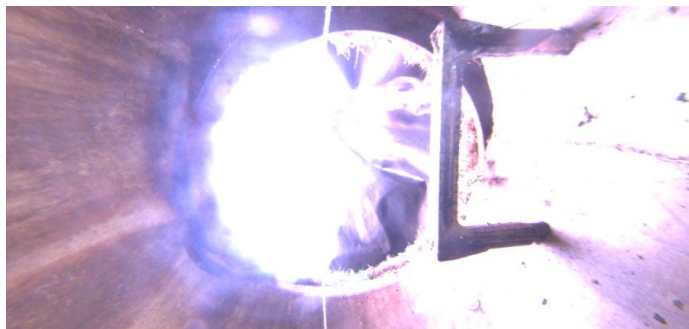
Code: **MGP**
Description: **General Photo**

Distance (ft): **2.4**
Structural Grade: **0**
O&M Grade: **0**
Clock Start/From:
Clock To:
1st Value:
2nd Value:
Value Percent:
Step: **NO**
Remarks:

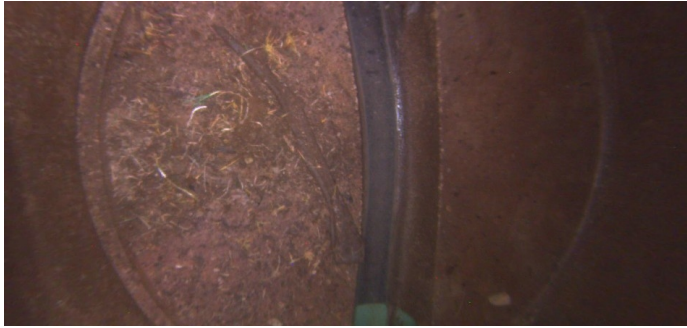
| Code: | MGO |
| Description: | General Observation |
| Distance (ft): | 6.9 |
| Remarks: | Ins. Comp. |
