Manhole Inspection Report

Date:	04/13/2018	Weather:		Coding:	RZMACP
MH#:	M-809-010	Owner:	NA	Len. Surveyed:	9.0
P.O.#:		Surveyor:	John Kuglmaier	Rim to Invert:	9.7
Customer:		Cert. #:	U-1215-07002349	Wall Material:	Concrete (reinforced)

Street:	Grosbeak Ct. 267' North of Tanager	Project:	Hobart, IN
City:	Hobart, IN	GPS Northing:	2908873.771
Location:		GPS Easting:	2908873.771
Drain Area:	Southwest	GPS Accuracy:	Sub-Meter
Cover Shape:	Circular	Evidence of Surcharge:	No
Cover Size:	22.5	Potential for Runoff:	None
Comments:

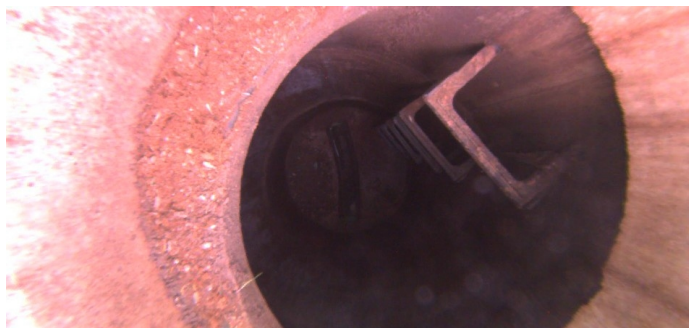
Code: **MGP**
Description: **General Photo**

Distance (ft): **.0**
Structural Grade: **0**
O&M Grade: **0**
Clock Start/From:
Clock To:
1st Value:
2nd Value:
Value Percent:
Step: **NO**
Remarks:

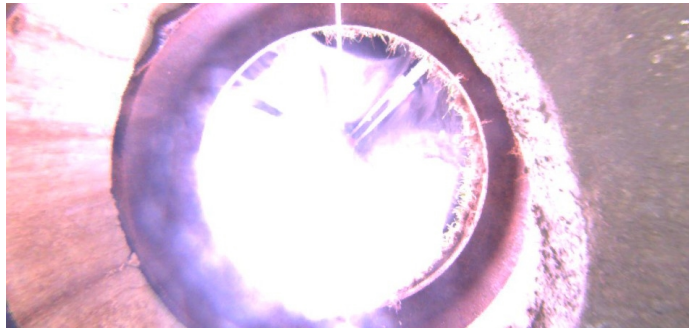
Code: **MGP**
Description: **General Photo**

Distance (ft): **2.2**
Structural Grade: **0**
O&M Grade: **0**
Clock Start/From:
Clock To:
1st Value:
2nd Value:
Value Percent:
Step: **NO**
Remarks:

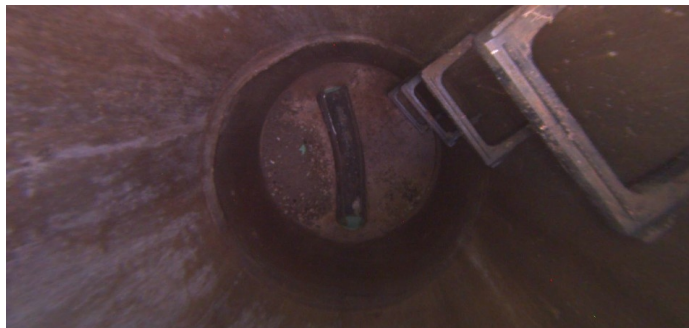
Code: **IS**
Description: **Infil Stain**

Distance (ft): **3.0**
Structural Grade: **0**
O&M Grade: **0**
Clock Start/From: **12**
Clock To: **12**
1st Value:
2nd Value:
Value Percent:
Step: **NO**
Remarks:

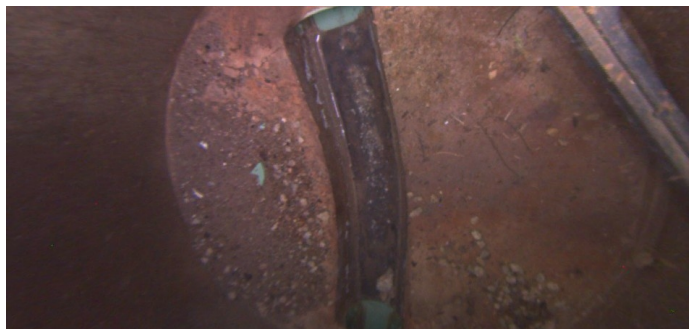
Code: **DSGV**
Description: **Deposits Settled Gravel**

Distance (ft): **7.1**
Structural Grade: **0**
O&M Grade: **2**
Clock Start/From: **7**
Clock To: **11**
1st Value:
2nd Value:
Value Percent: **5.000**
Step: **NO**
Remarks:

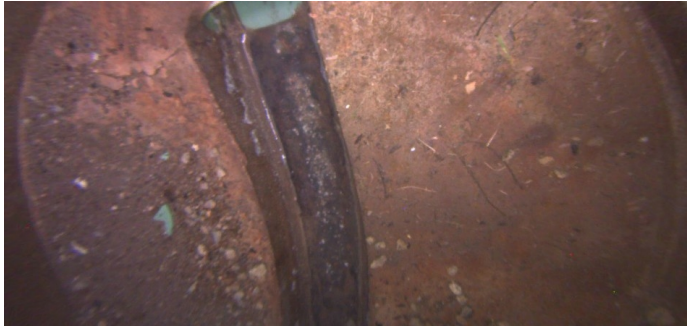
Code:	MGO
Description:	General Observation
Distance (ft):	7.7
Structural Grade:	0
O&M Grade:	0
Clock Start/From:	
Clock To:	
1st Value:	
2nd Value:	
Value Percent:	
Step:	NO
Remarks:	Ins. Comp.
